Financuar nga  
Bashkimi Evropian

ITALIAN AGENCY  
FOR DEVELOPMENT  
COOPERATION

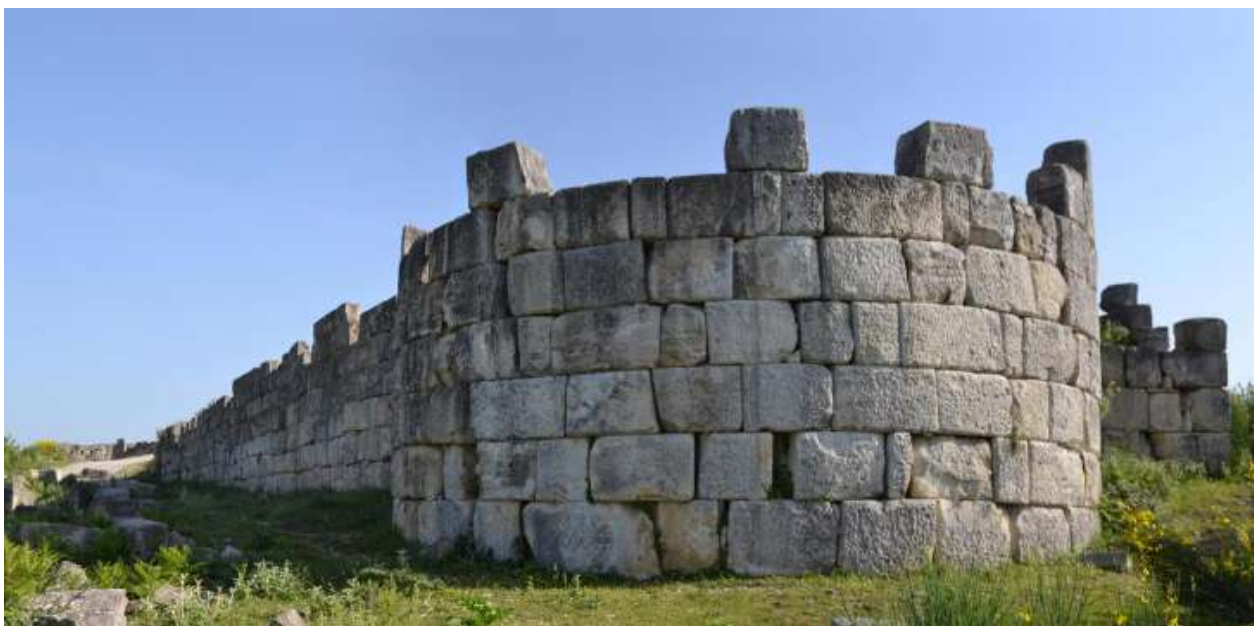
Figure 4 The Round Tower. Photo by N. Ceka

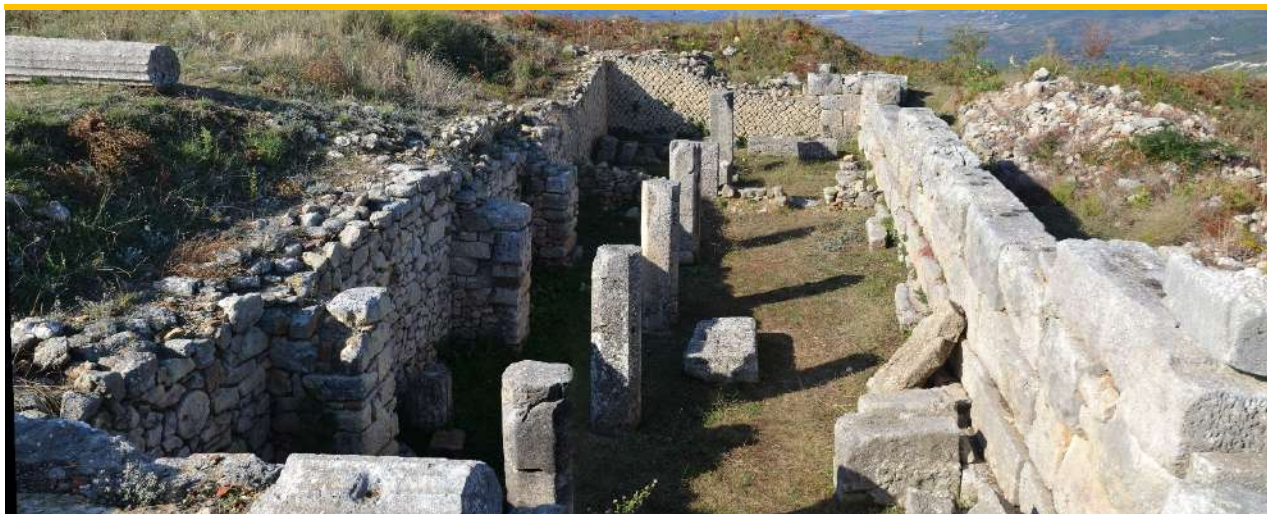
*Figure 22 Arsenal after the restoration*

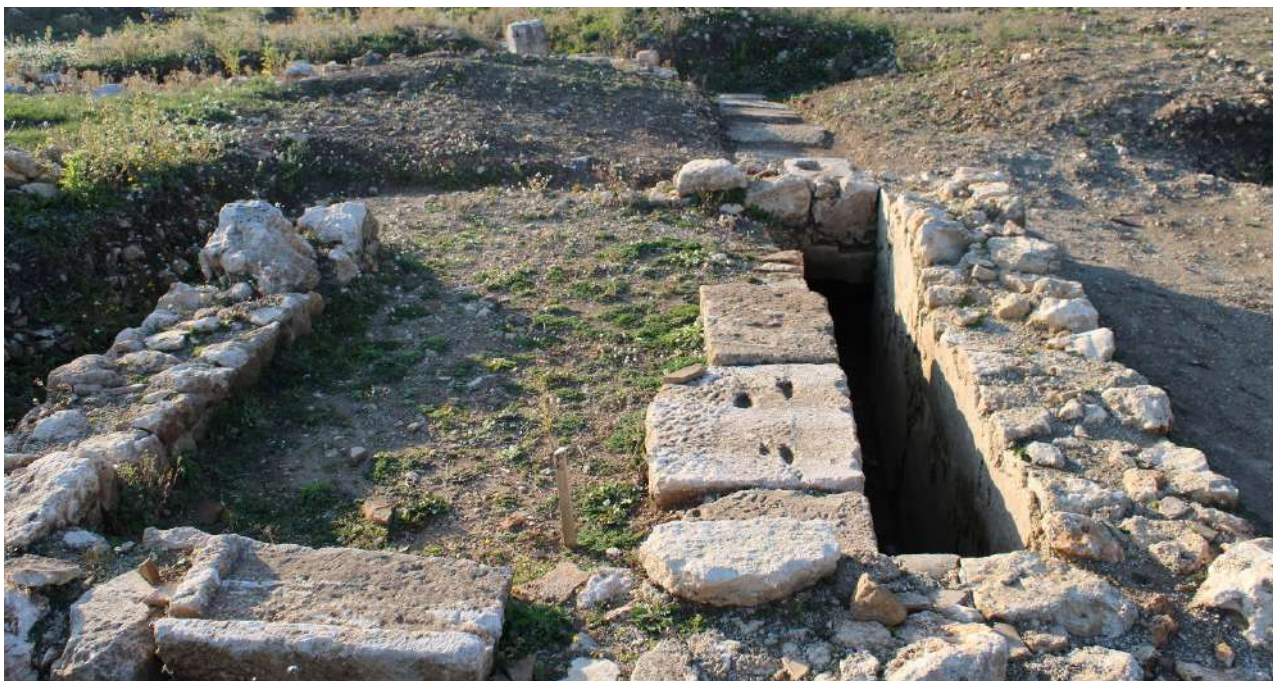
Photographic documentation - Latrina

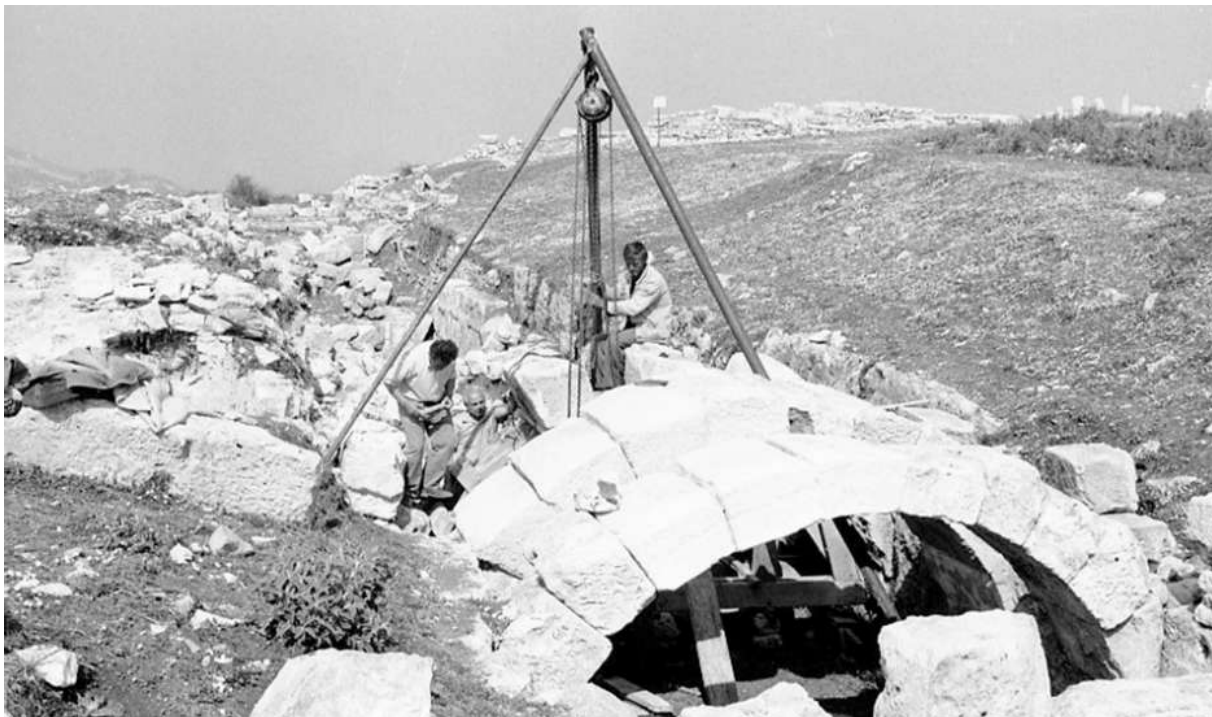
Figure 38 Restoration of the cistern's arches. L. Papajani 1987

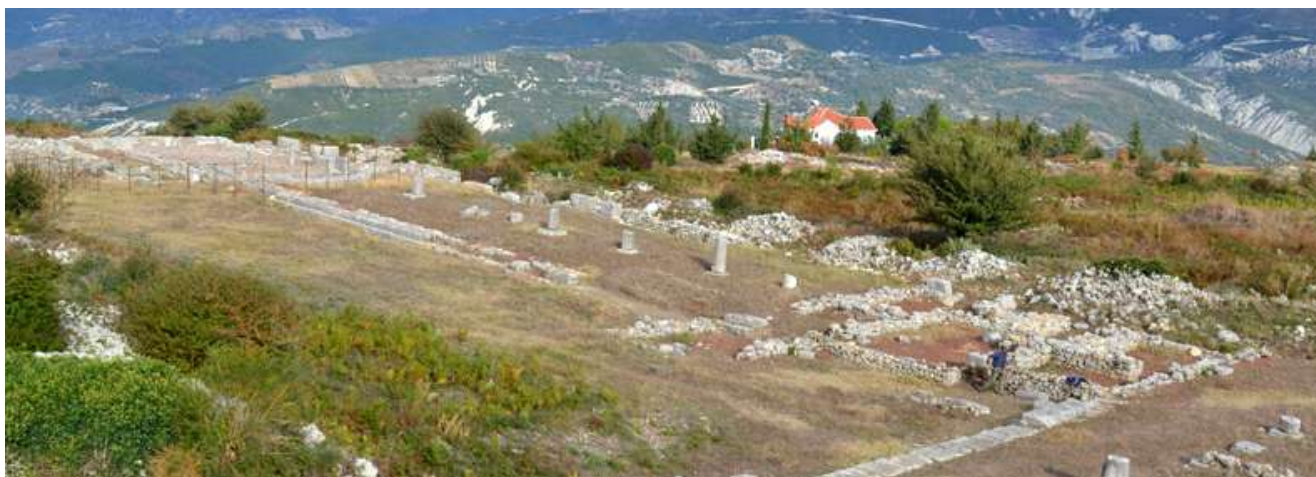
Figure 41 Stoa A. View and the plan

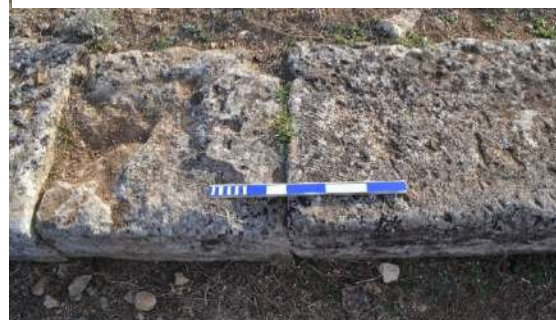
## 2.6 Gymnasium and Roman Baths

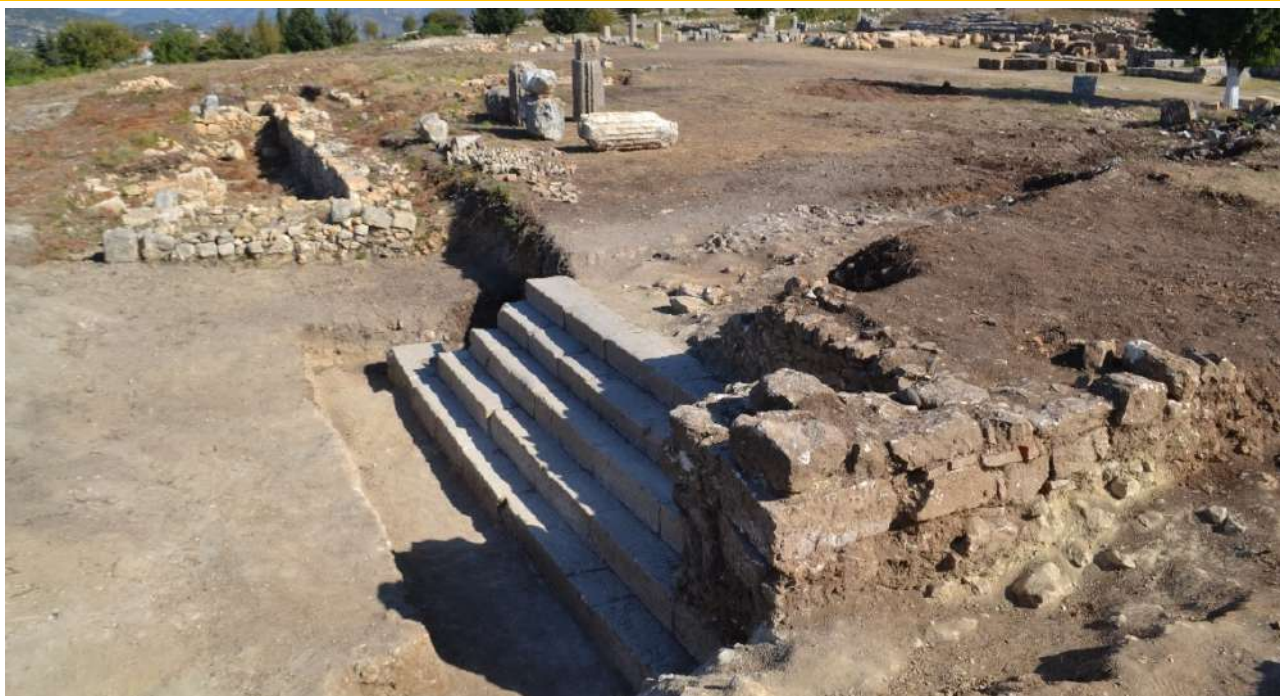
Figure 59 The staircase of the Augustus Tempel

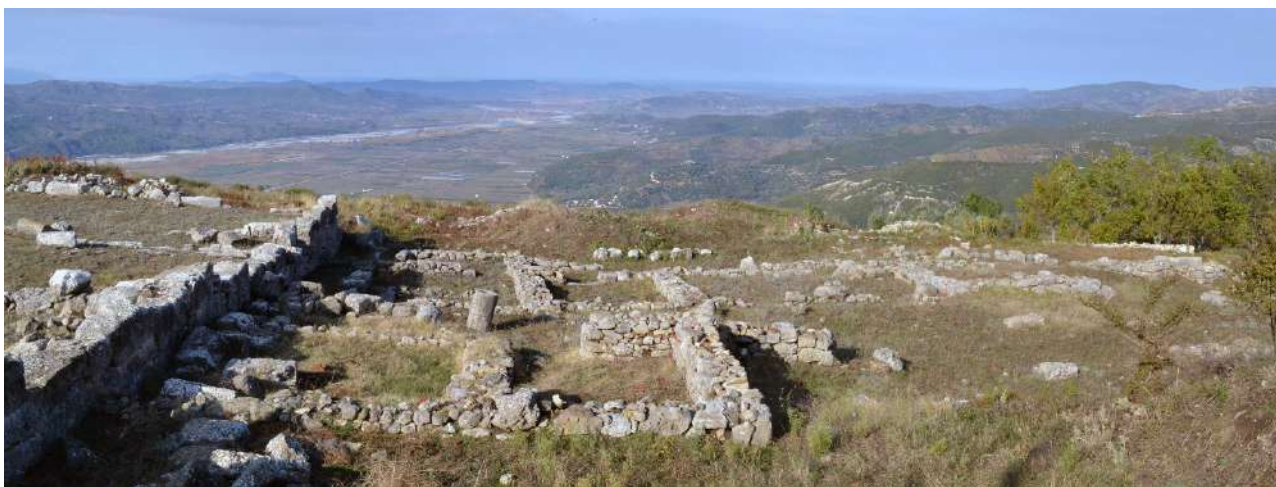
Figure 69 Dwelling C

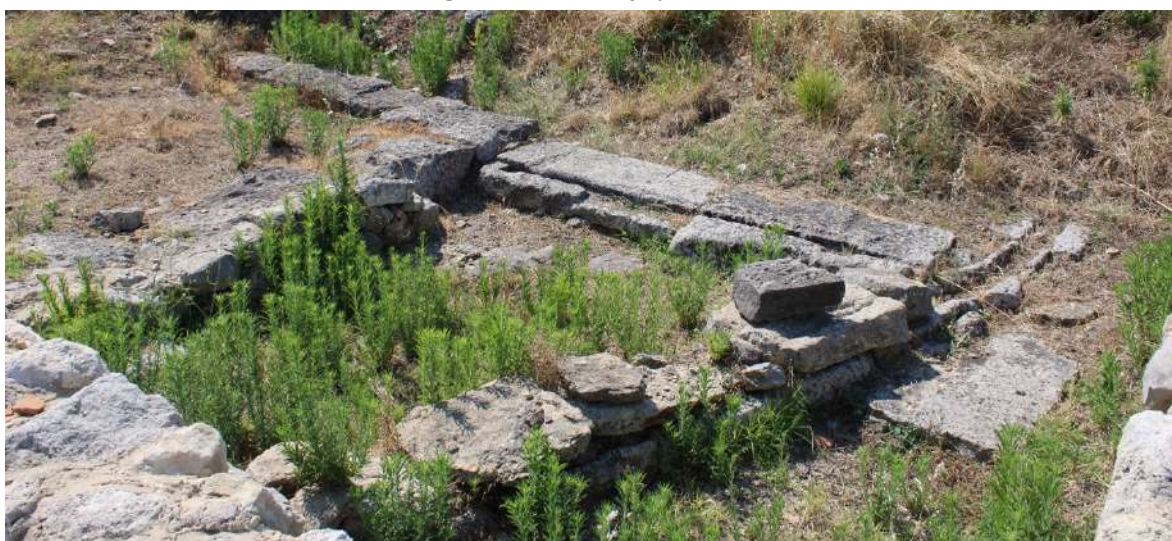
### 3.4 Marcus Lollianus inscription

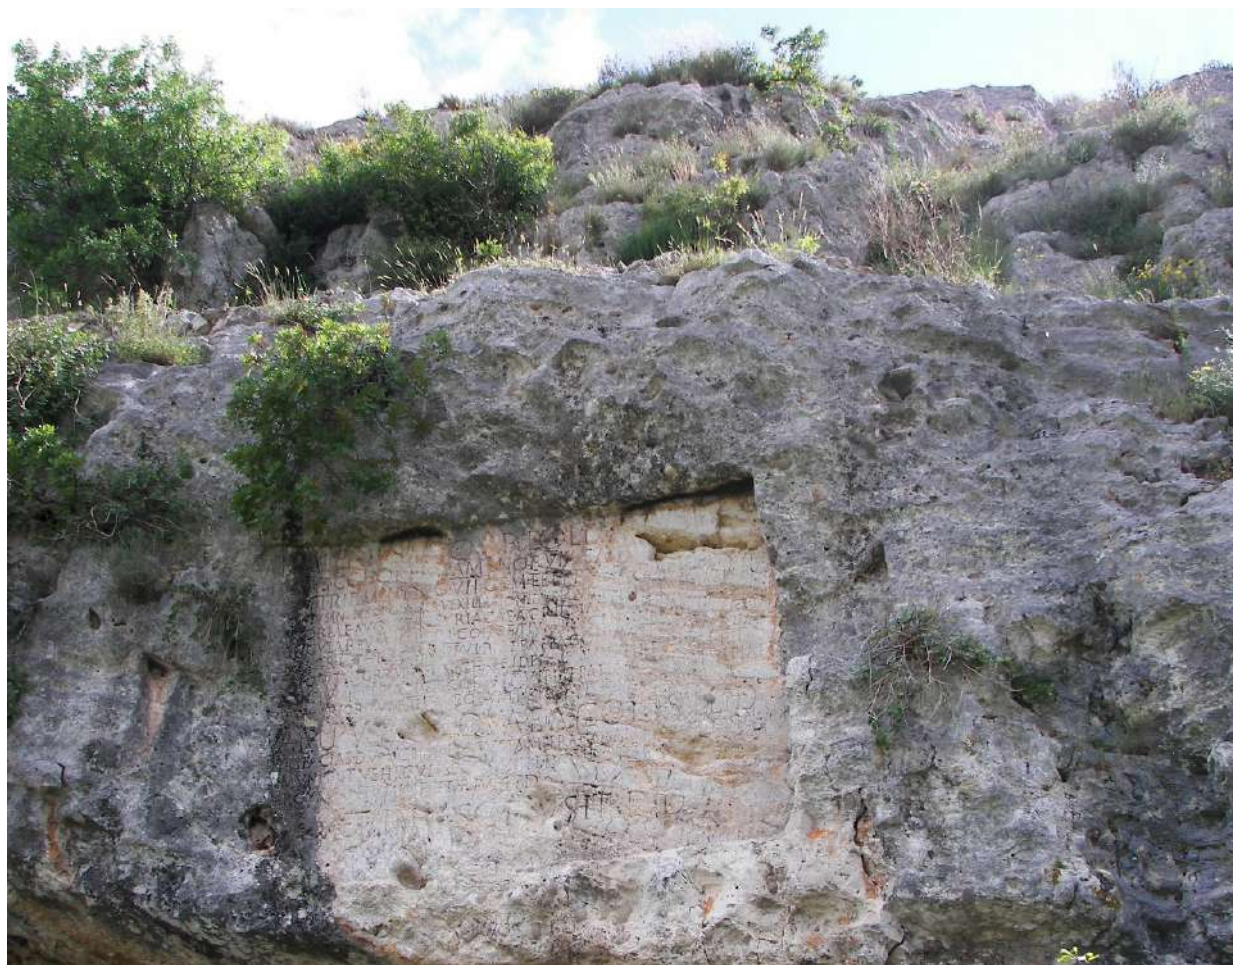
Figure 75 Tabula ansata of the inscript

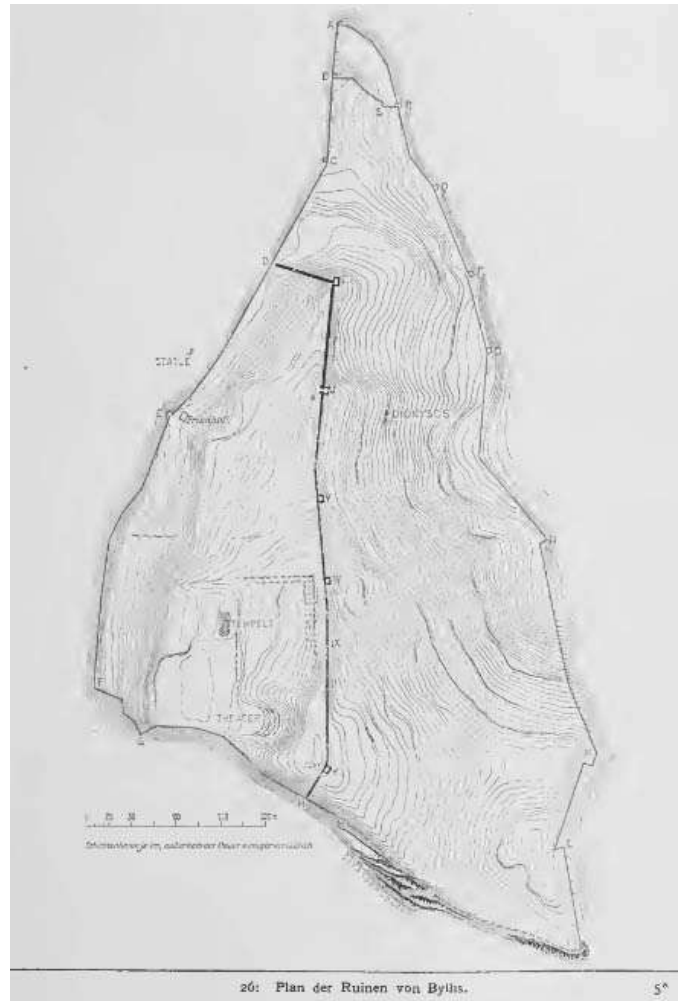
Figure 77 Victorinus wall inside the Bylliones city wall

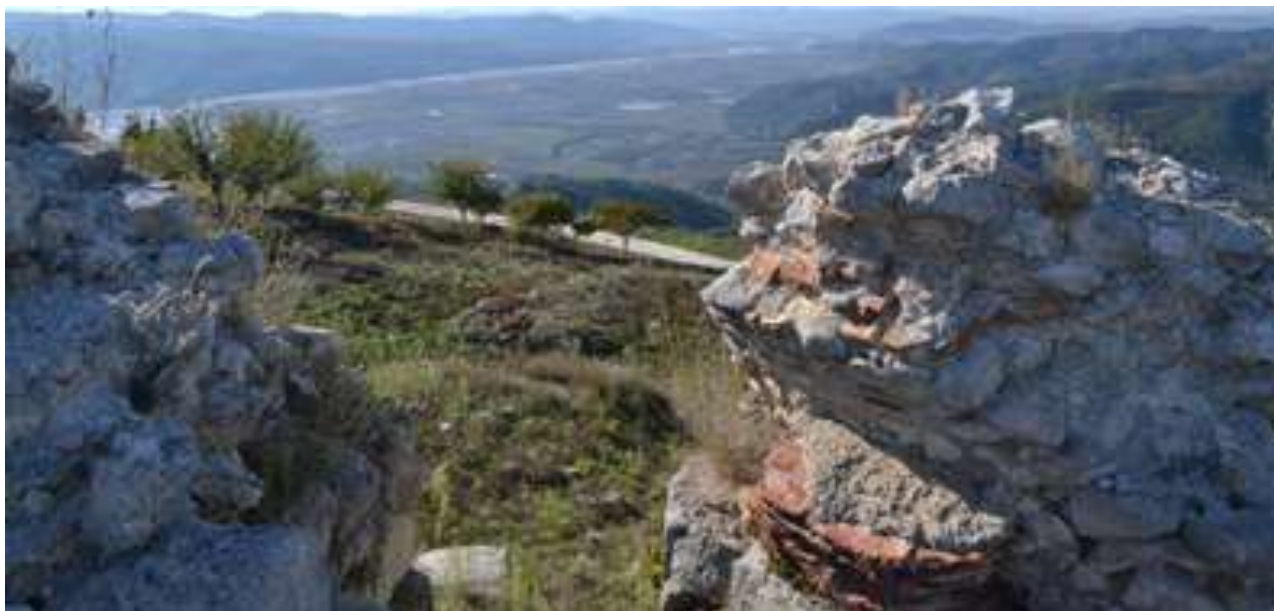
Photographic documentation - Tower S

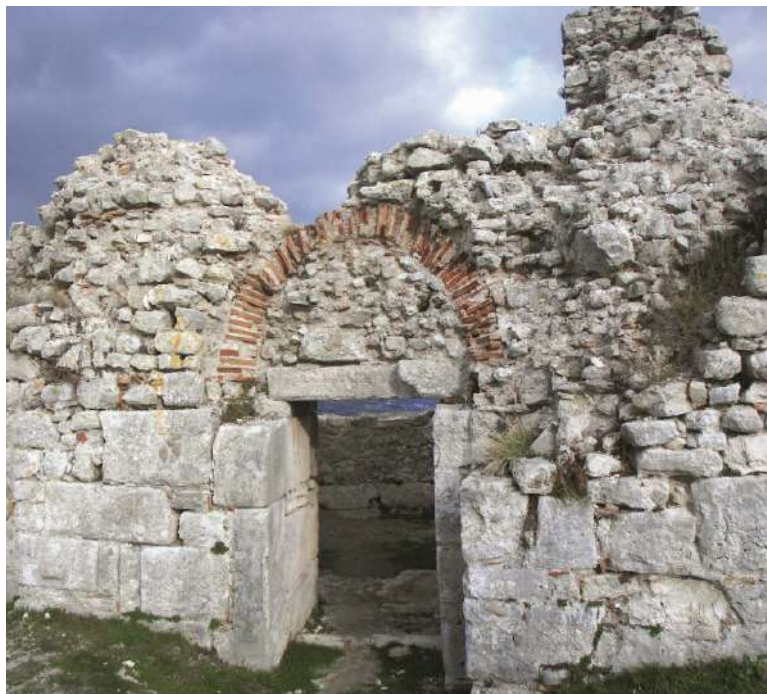
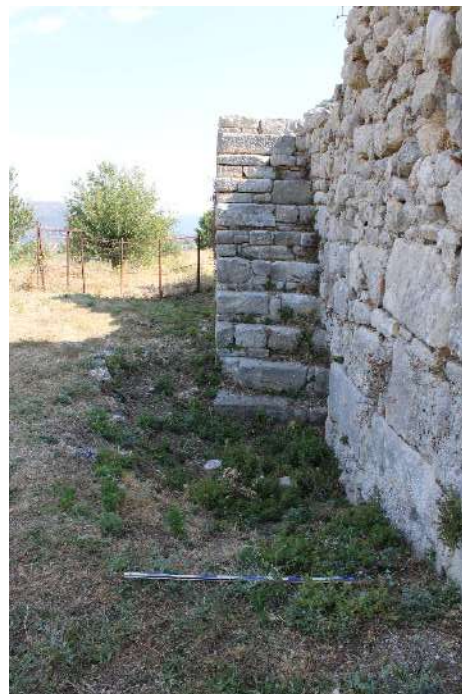
Figure 81 Tower T. The gate and staircases

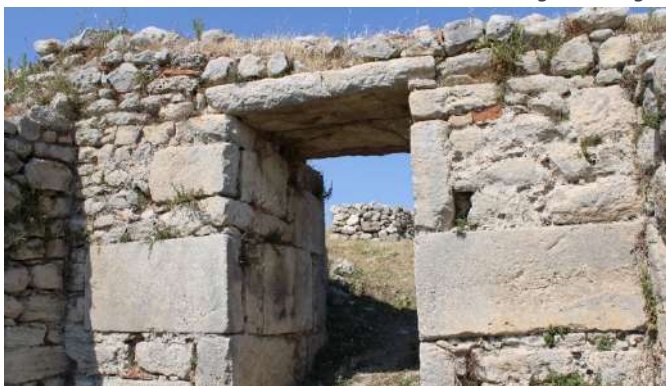
Figure 87 The tower's U gate. The cracked architraves

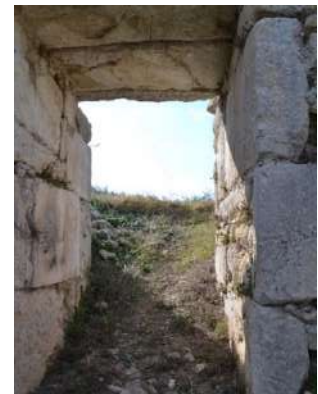
Photographic documentation - The wall between U and V

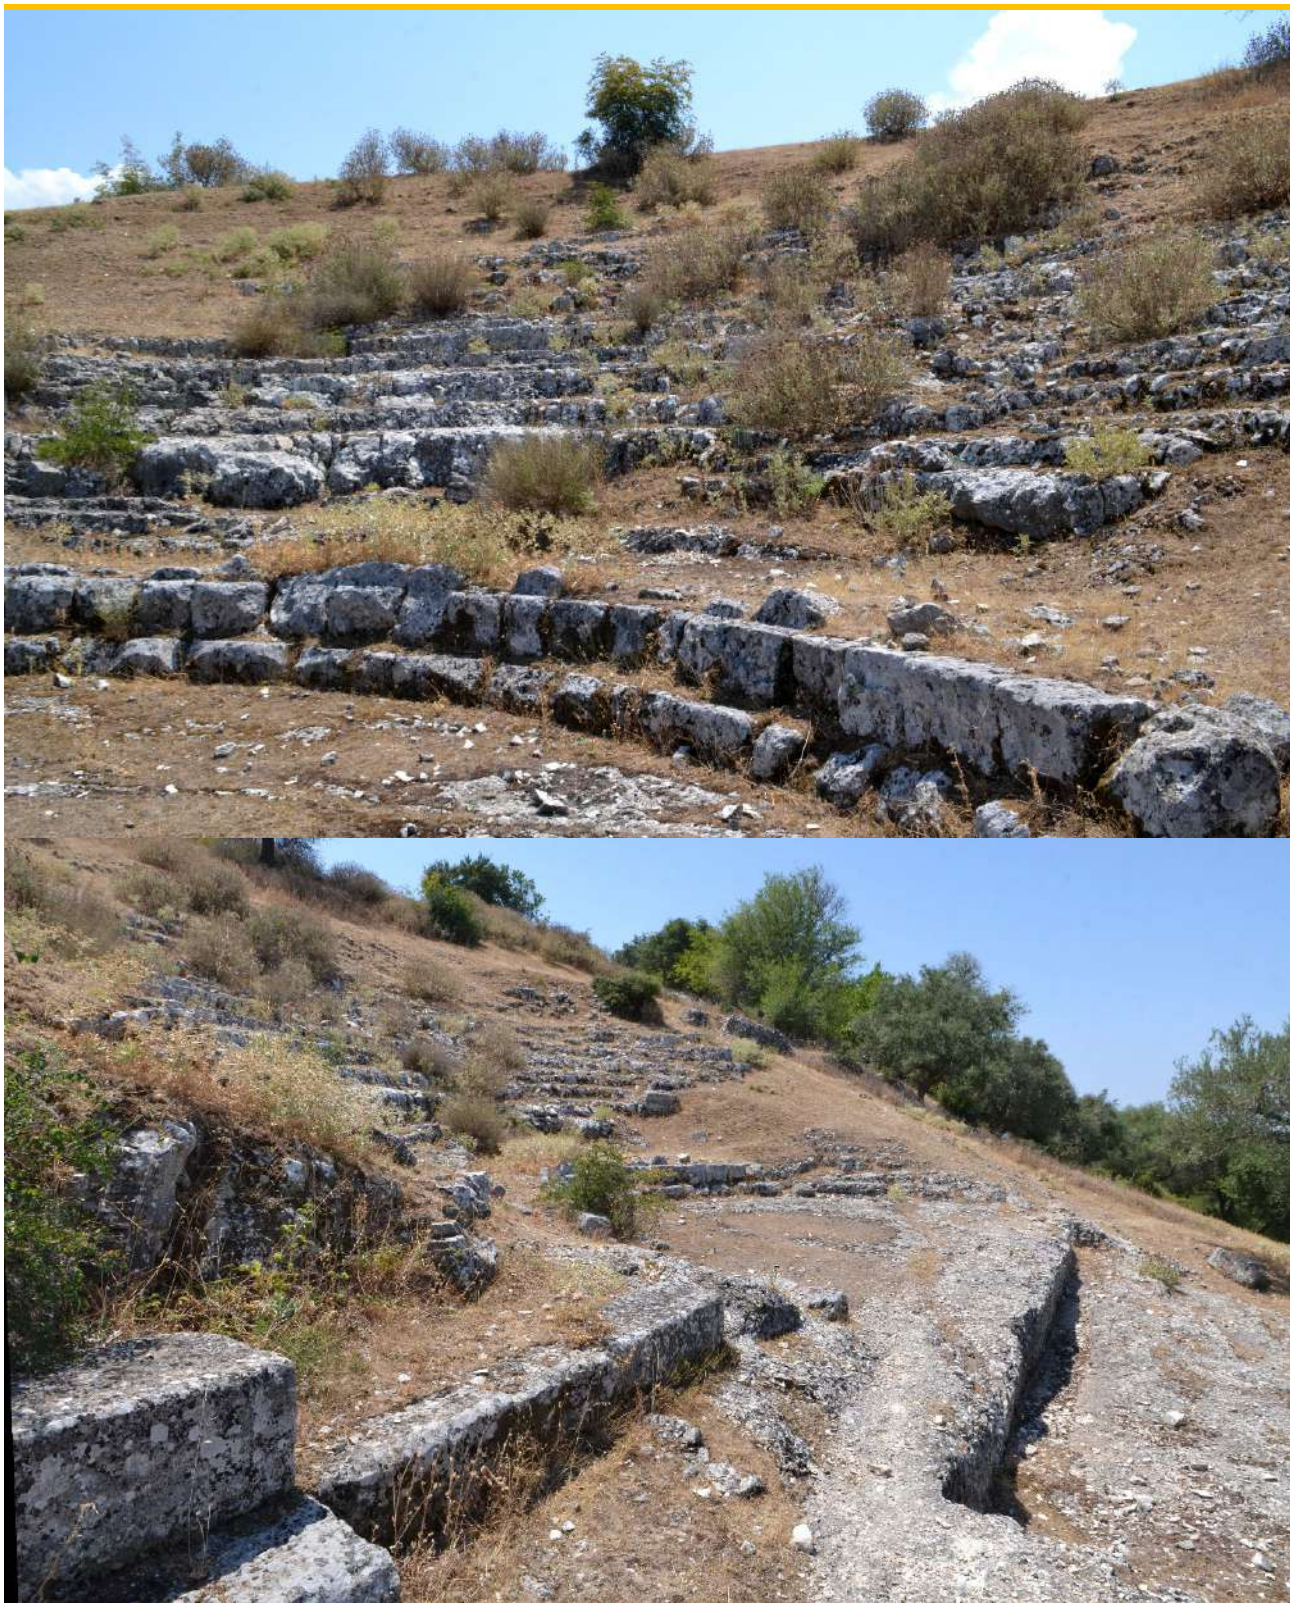
Photographic documentation - Theatre

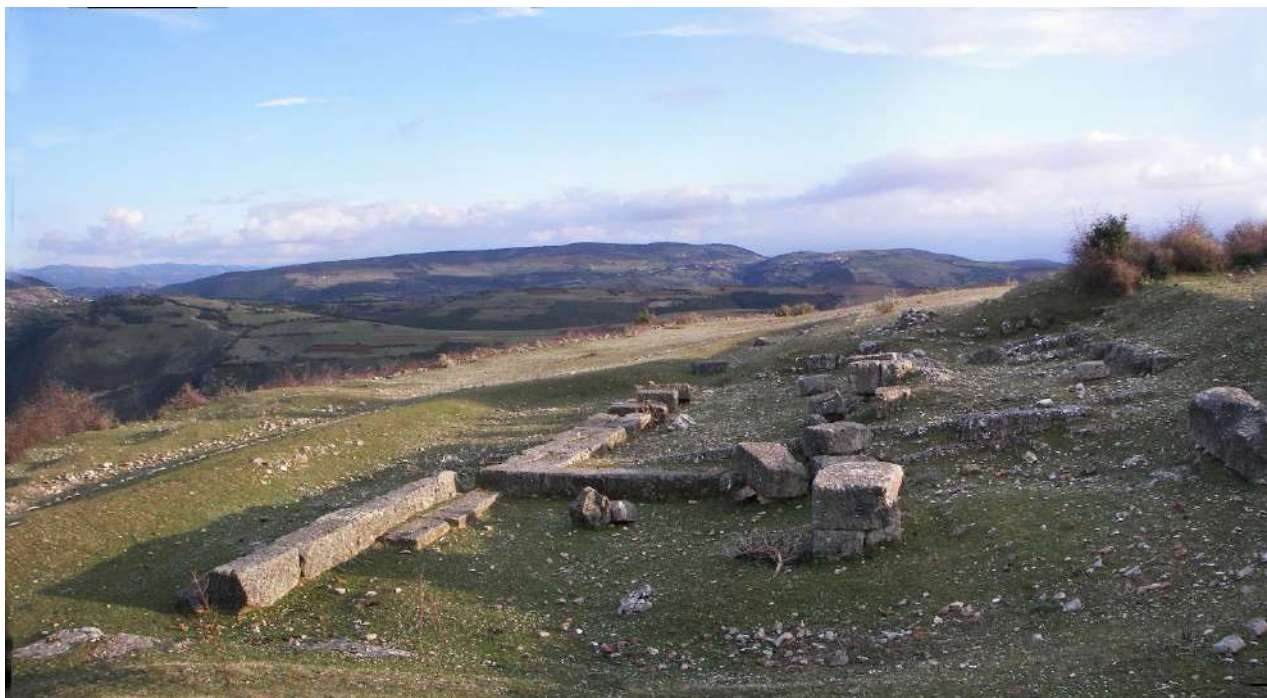
Photographic documentation - Stoa

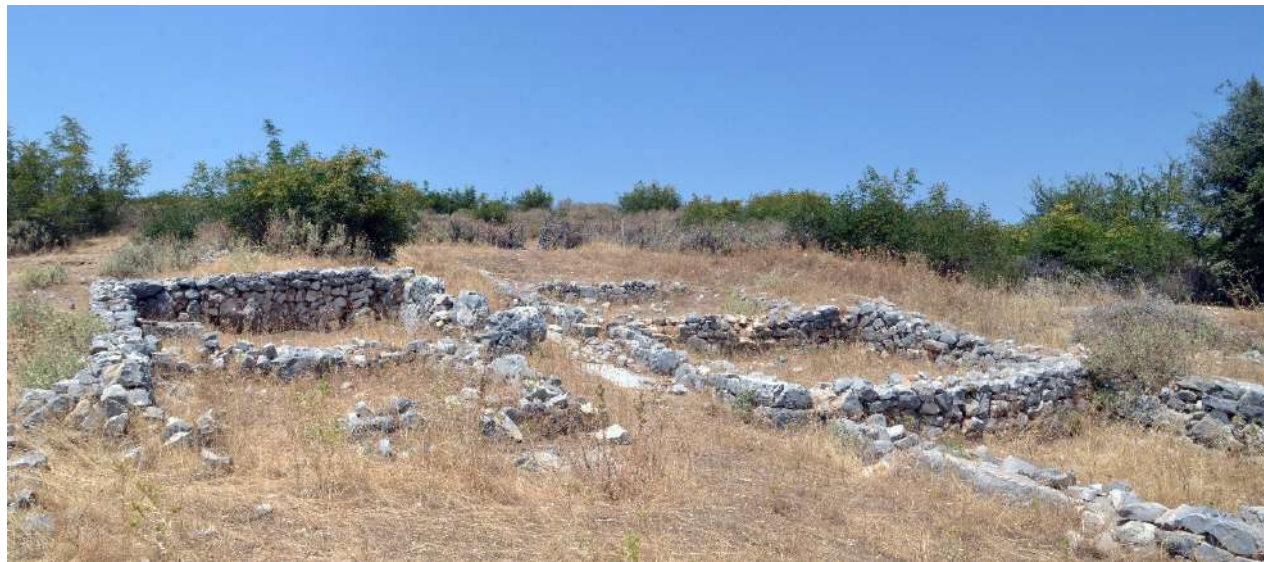
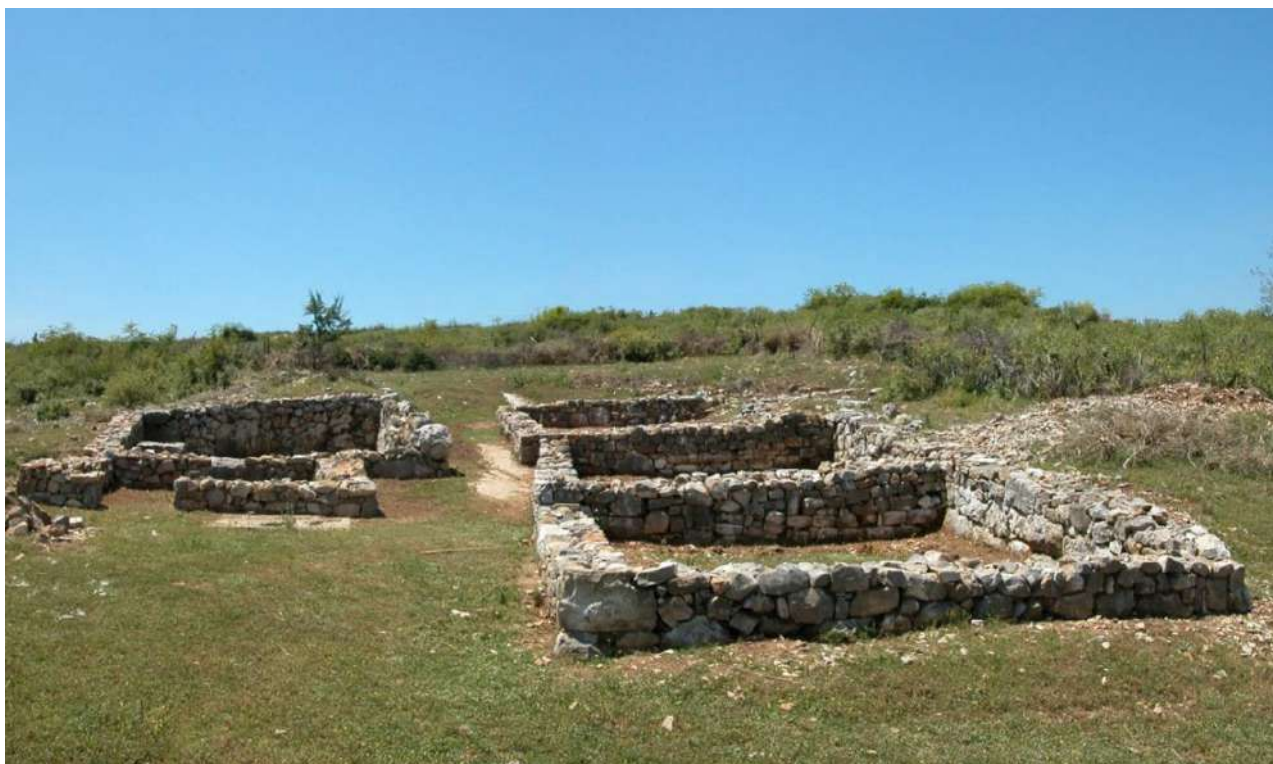
*Figure 126 Dwelling 2019-2025*

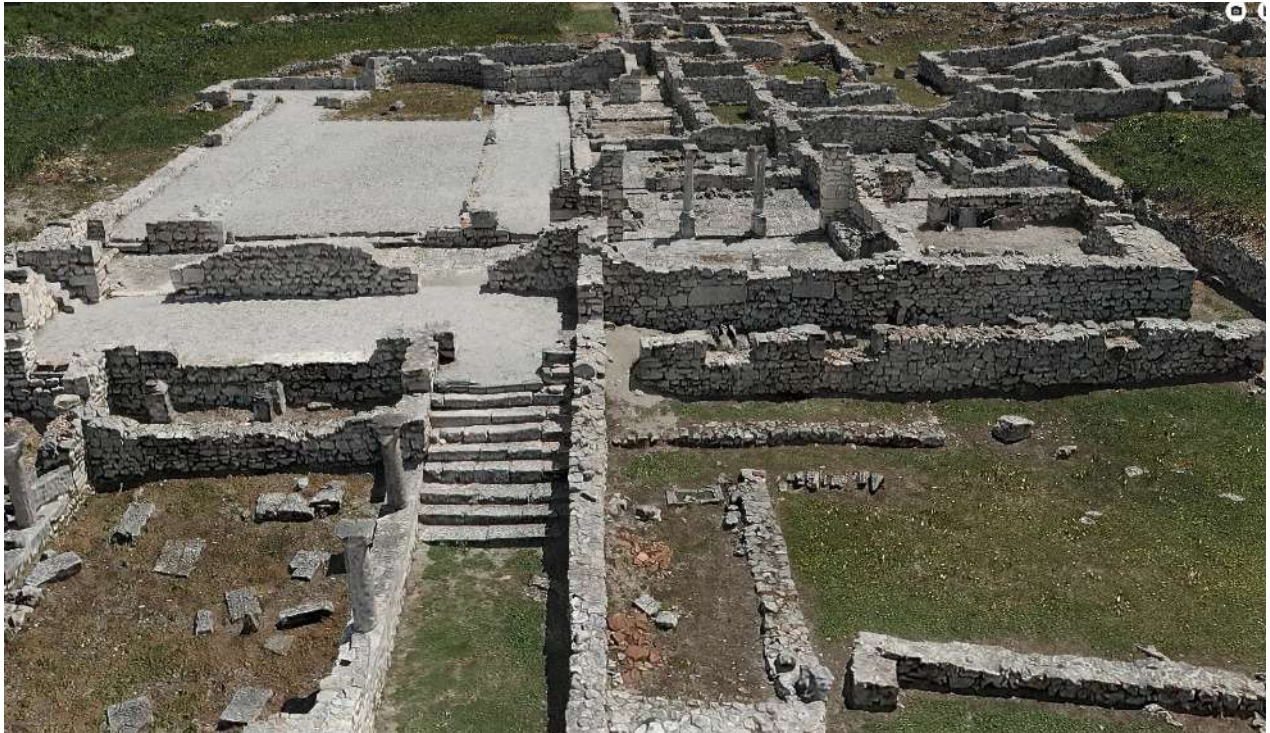
Figura 8 Level of Details from 3D Model

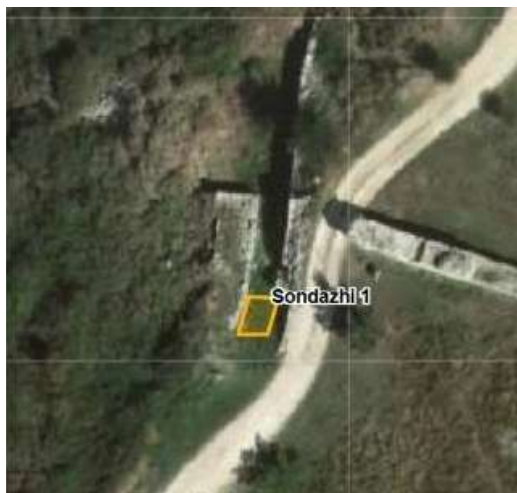
According to the Inception Plan, it is recommended that visitors enter the closed monumental area of the Bylis Archaeological Park through Gate No. 6, where the ticket office will also be located.

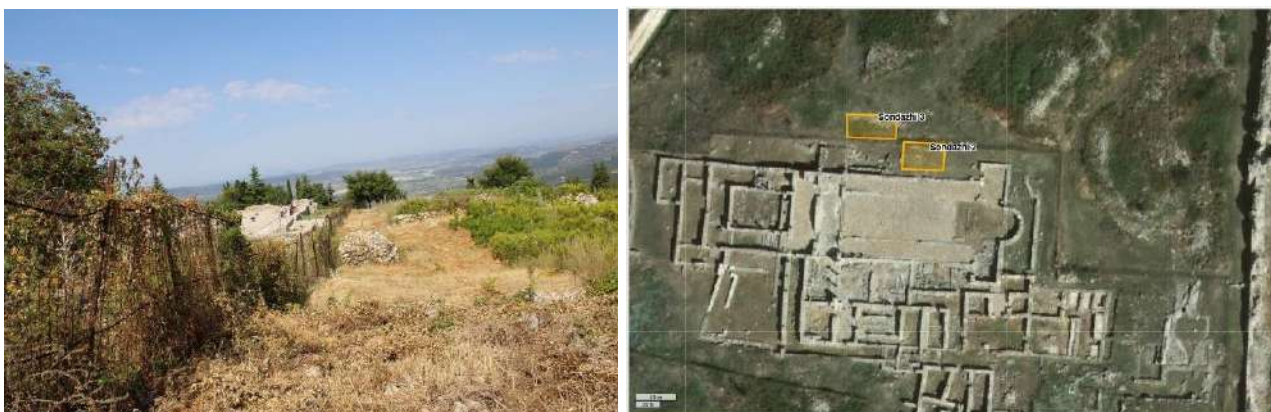
*Figura 3 Bylis. Basilica B. Photo of the environment where the surveys will be carried out and Orthophoto 2015*

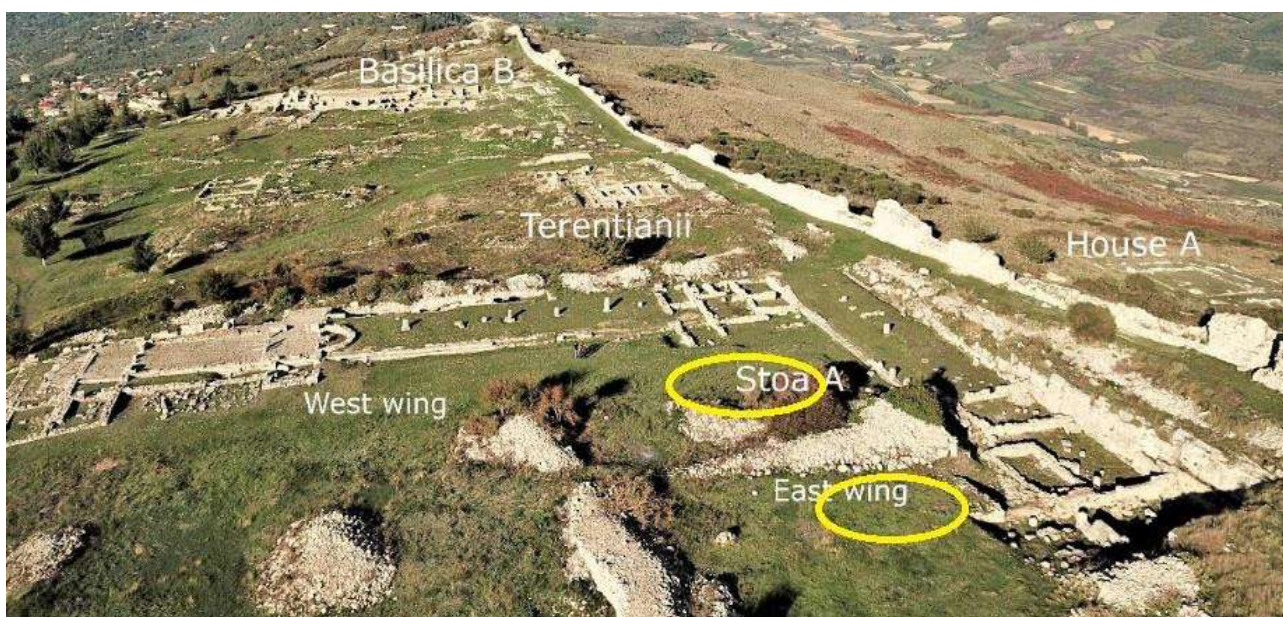
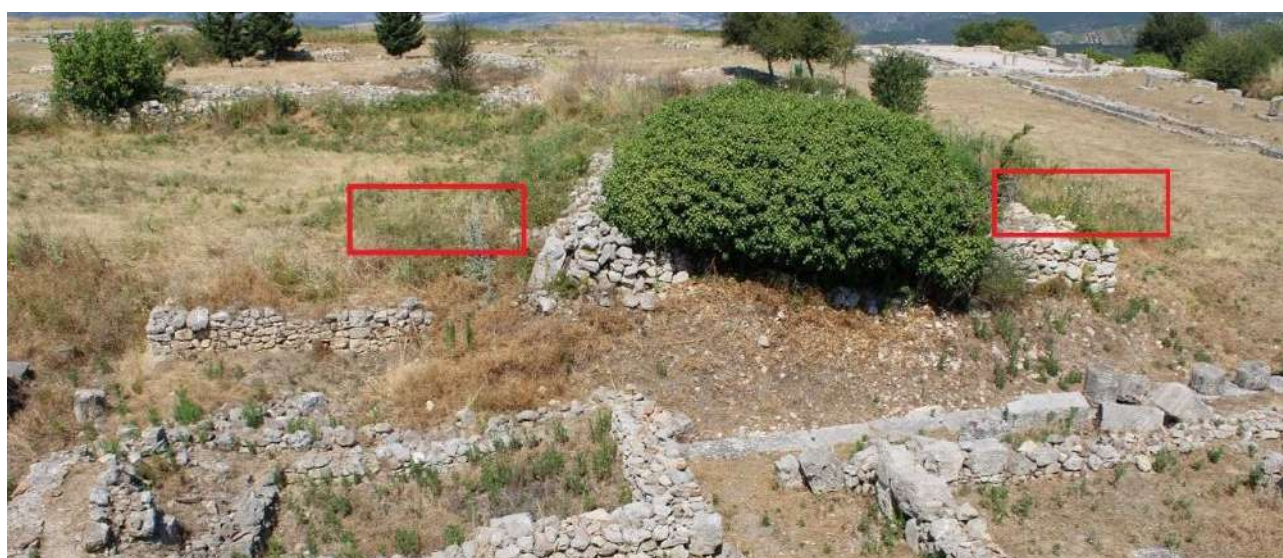
Figura 7 Stoa A. Polling locations and current situation overview

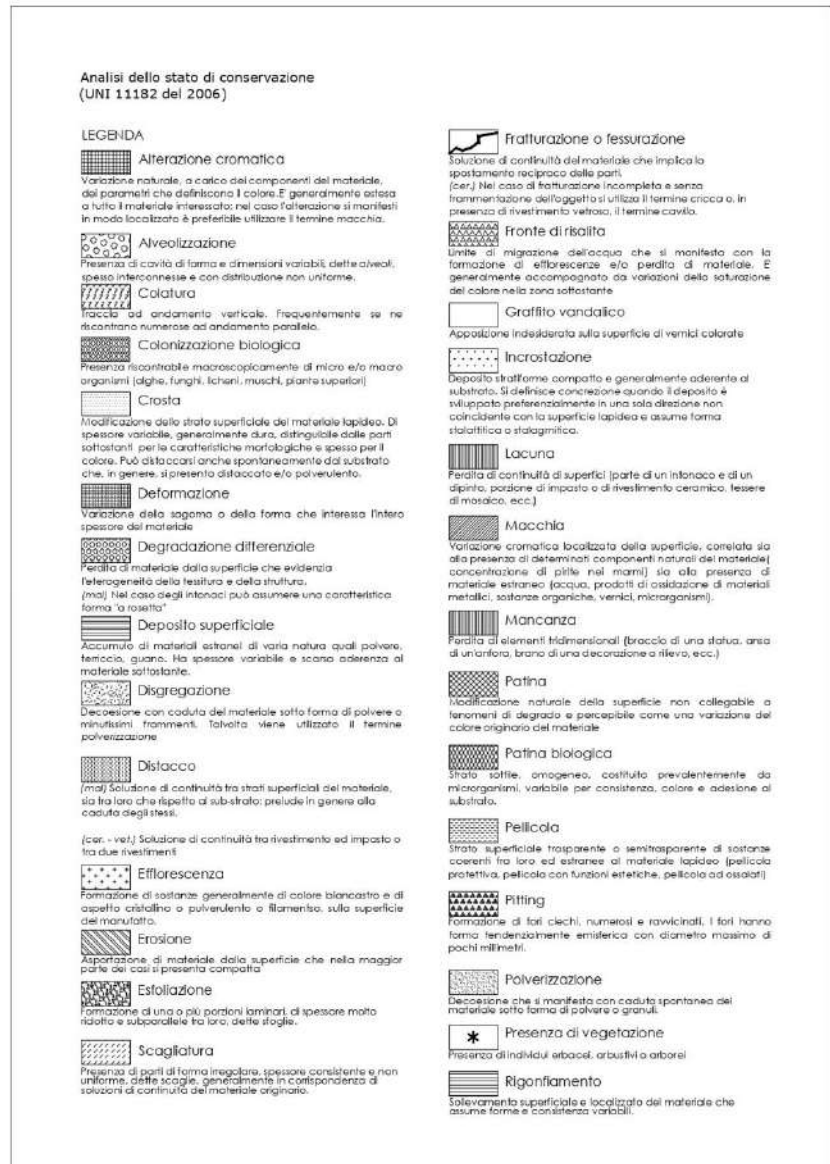
**Color Alteration**

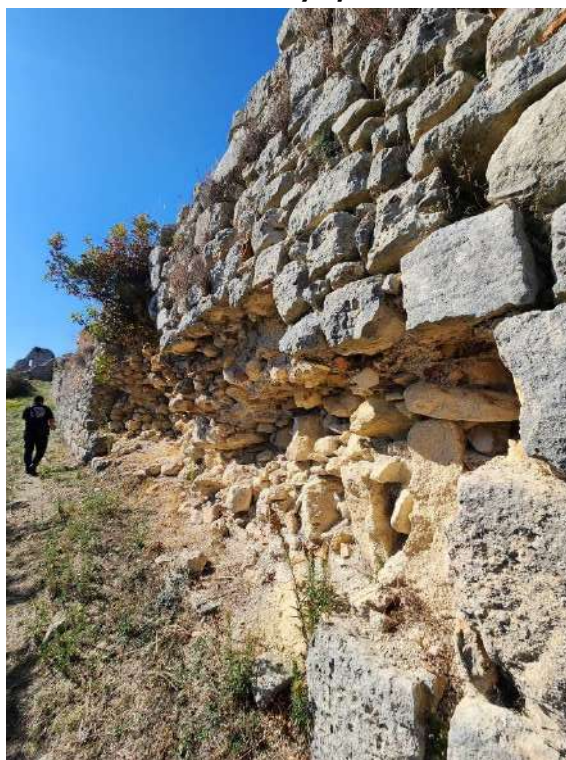
*Figure 1 Structural condition of the Victorinus Wall located in the Section S-T from the external side, highlighting area of material loss, deterioration and large displacements*

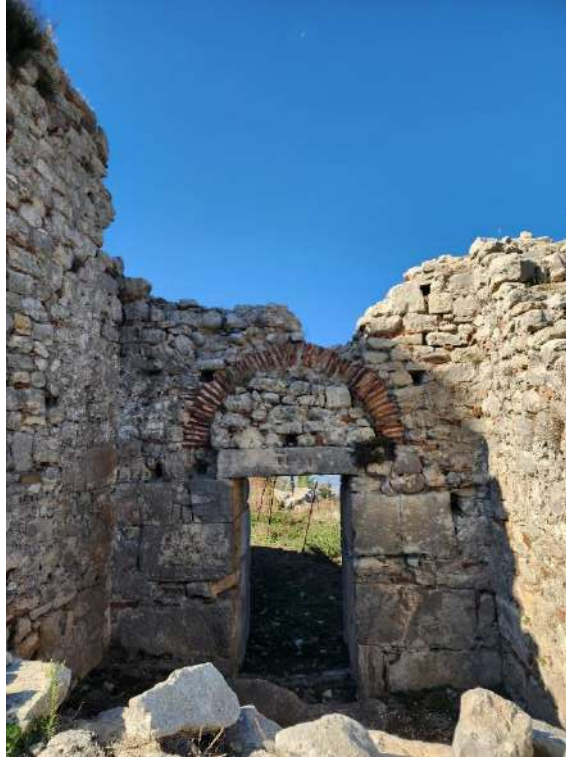
*Figure 2 View of the Tower T entrance, featuring a semicircular brick arch above a stone lintel*

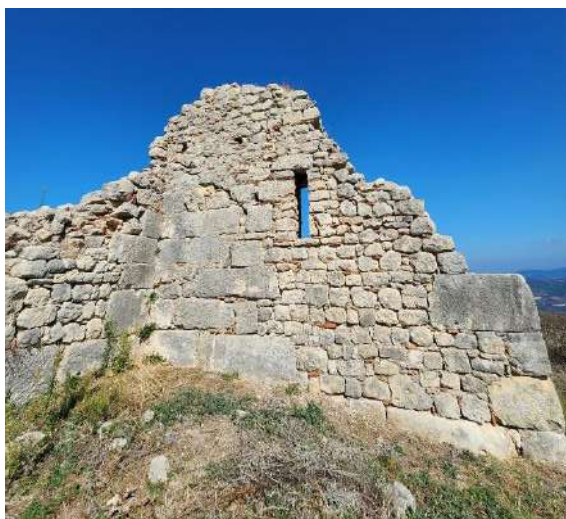
*Figure 4 Exterior frontal view of the Victorious Wall located in the Section T-U, highlighting diagonal cracking, indicating the risk of imminent collapse*

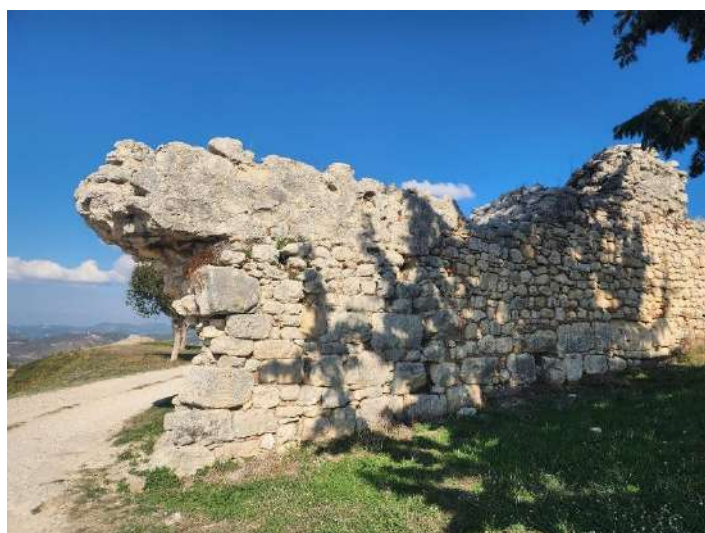
*Figure 6 Critical condition of the Victorinus Wall in the entrance of the Gate no.6*

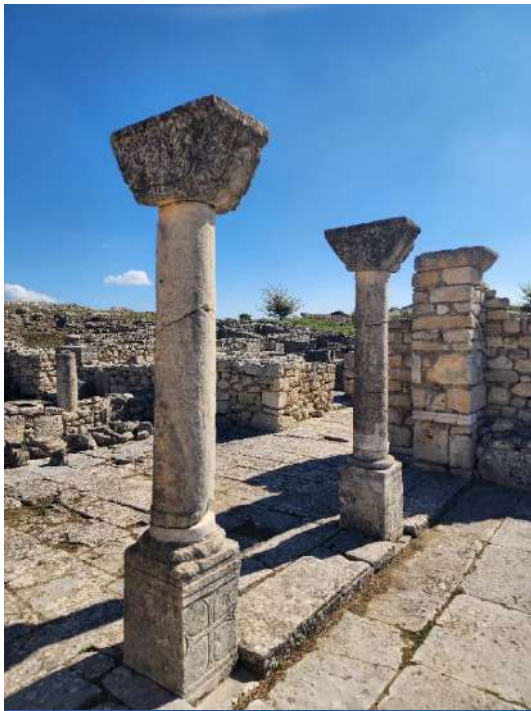
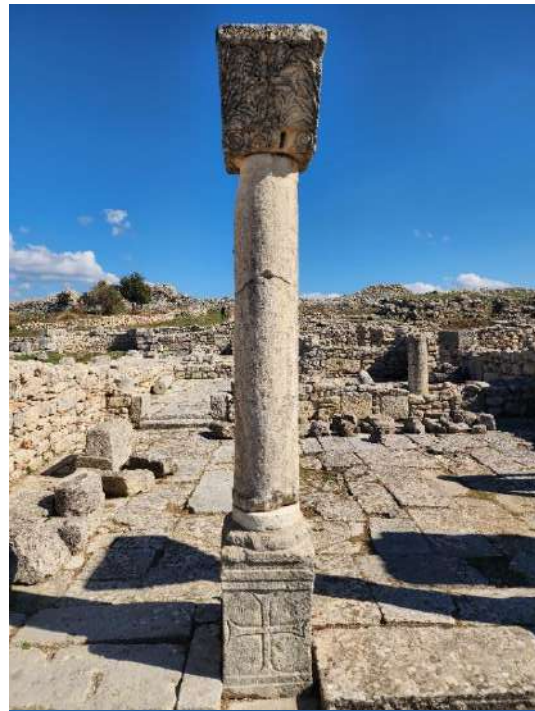
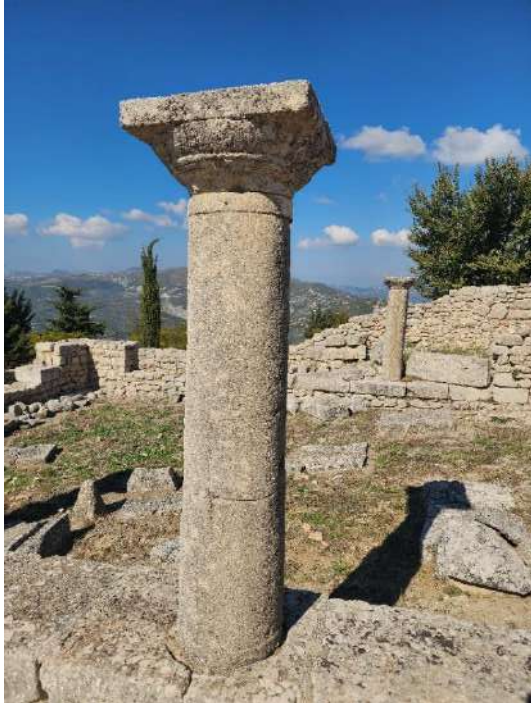
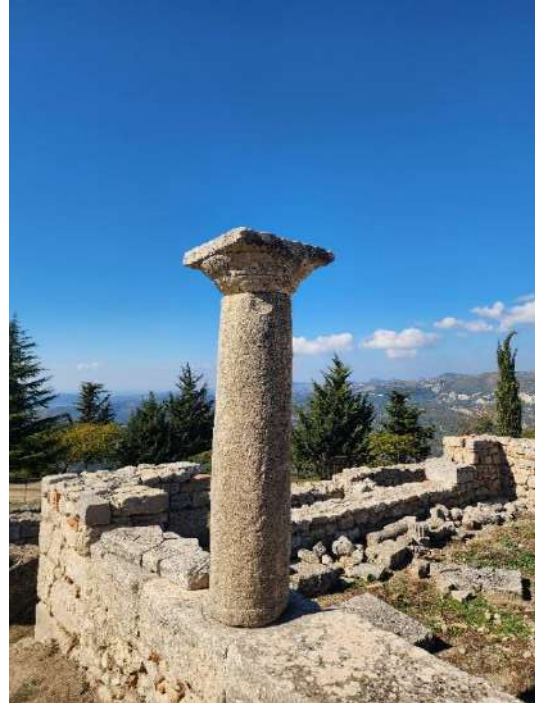
*Figure 8 Critical condition of colonnades at Basilica B present a risk of overturning and detachment from their capitals*

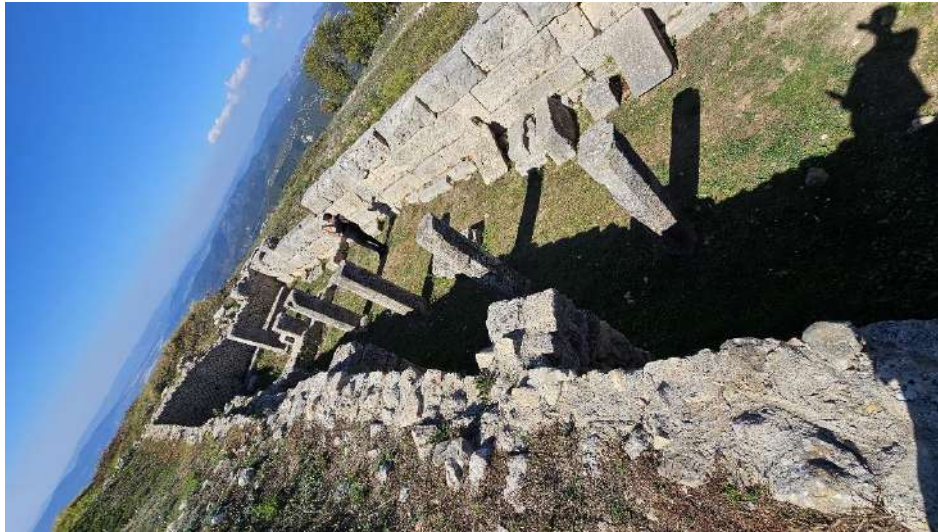
*Figure 9 Arsenal after restoration. A risk of colonnades overturning has been observed*

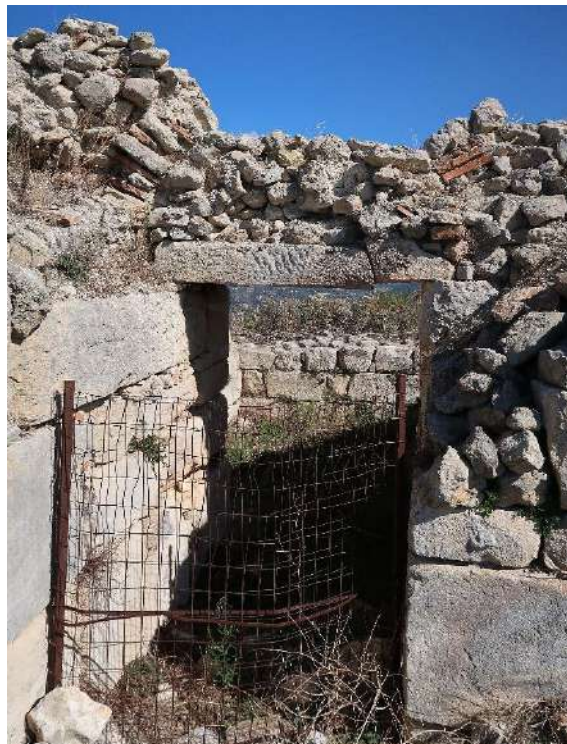
*Figure 10 Critical cracks of the lintel in the entrance of the Tower X*
