Financuar nga  
Bashkimi Evropian

ITALIAN AGENCY  
FOR DEVELOPMENT  
COOPERATION

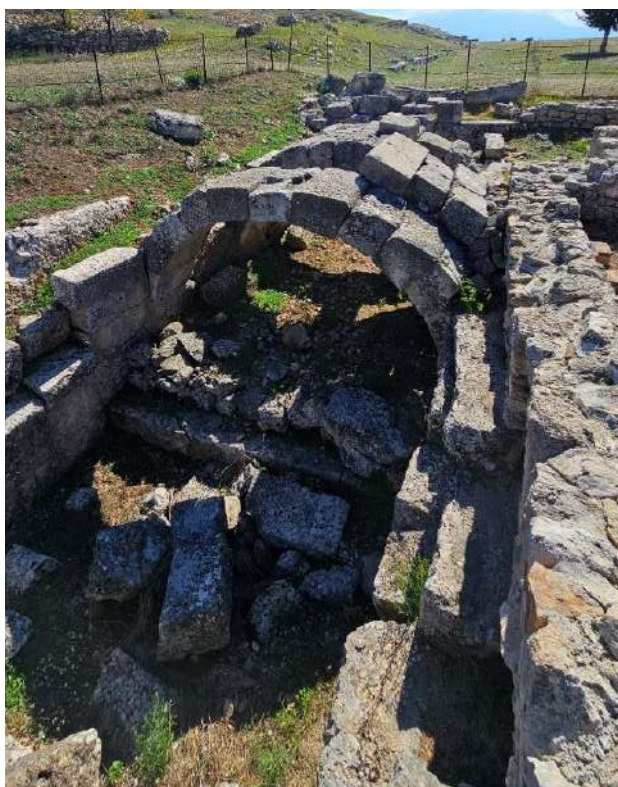
*Figure 11 Structural intervention to be carried out on the arch bridge located at the Cystem area, involving crack injection procedure*

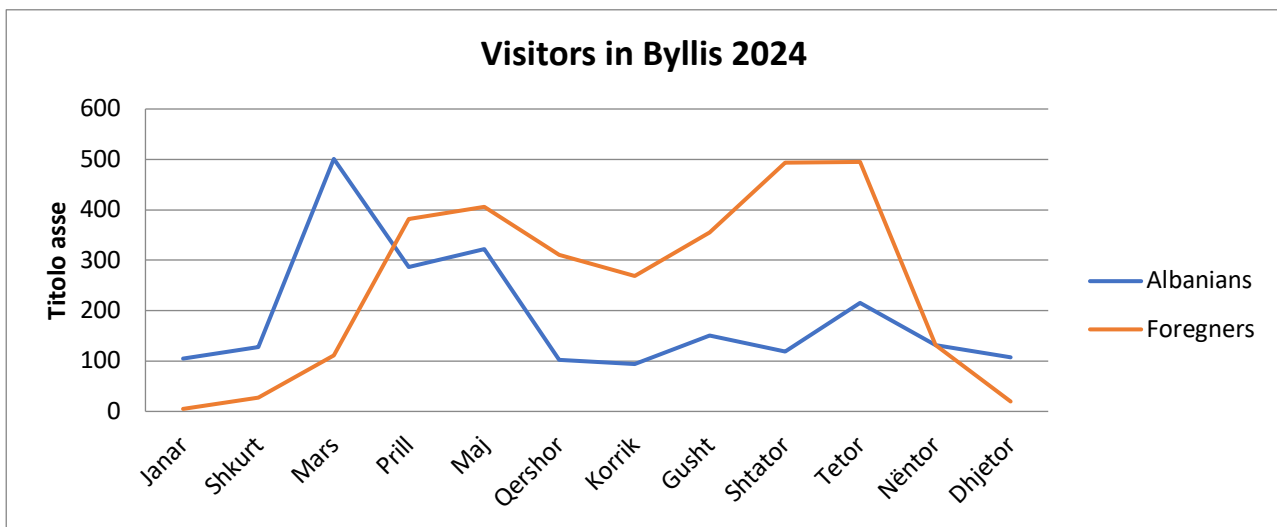
Source: Ministry of Culture; Ministry of Tourism and Environment

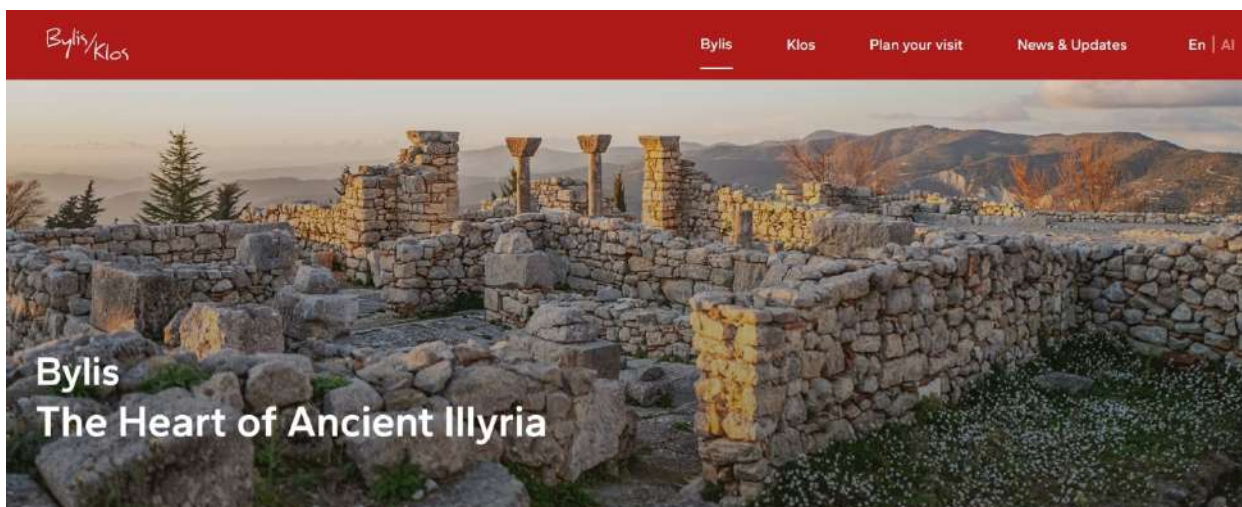
Figura 10 The view of Bylis webpage

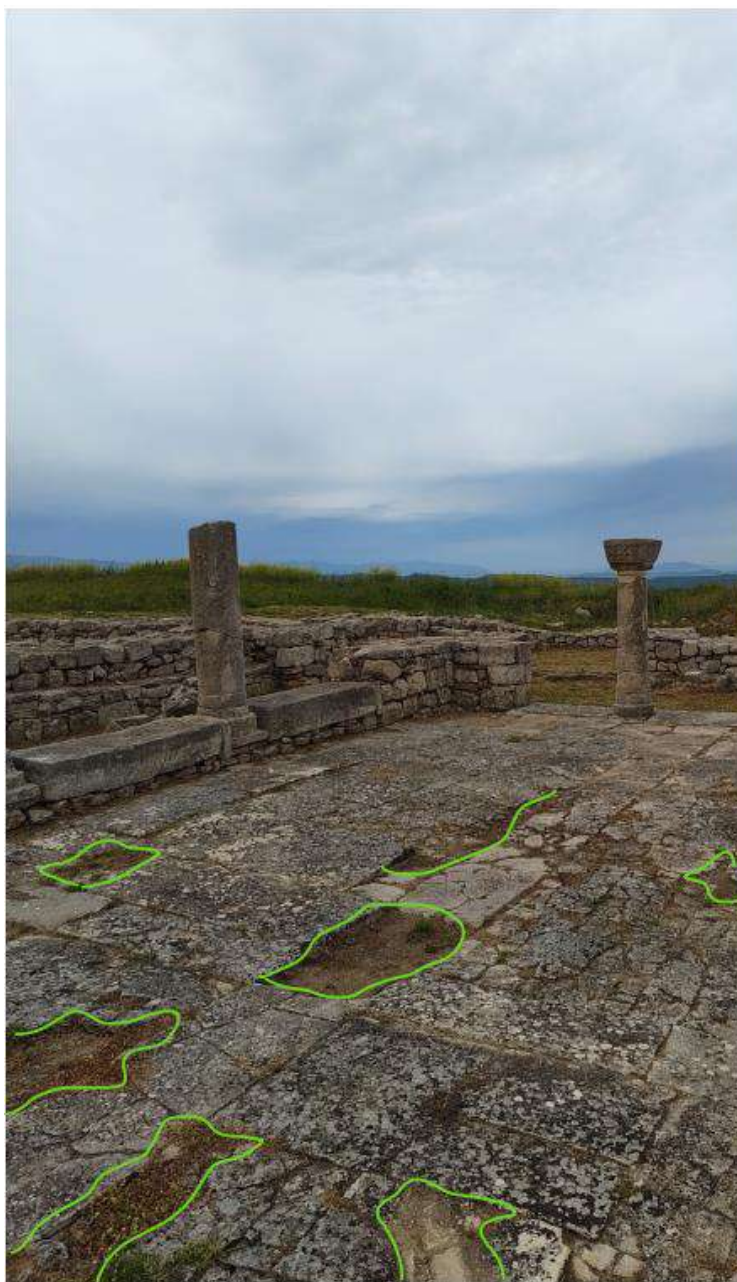
*Figure 2 Presence of biological patina and vegetation rooted in the joints of the paving of Basilica C, lacunae and cracks favouring the growth.*

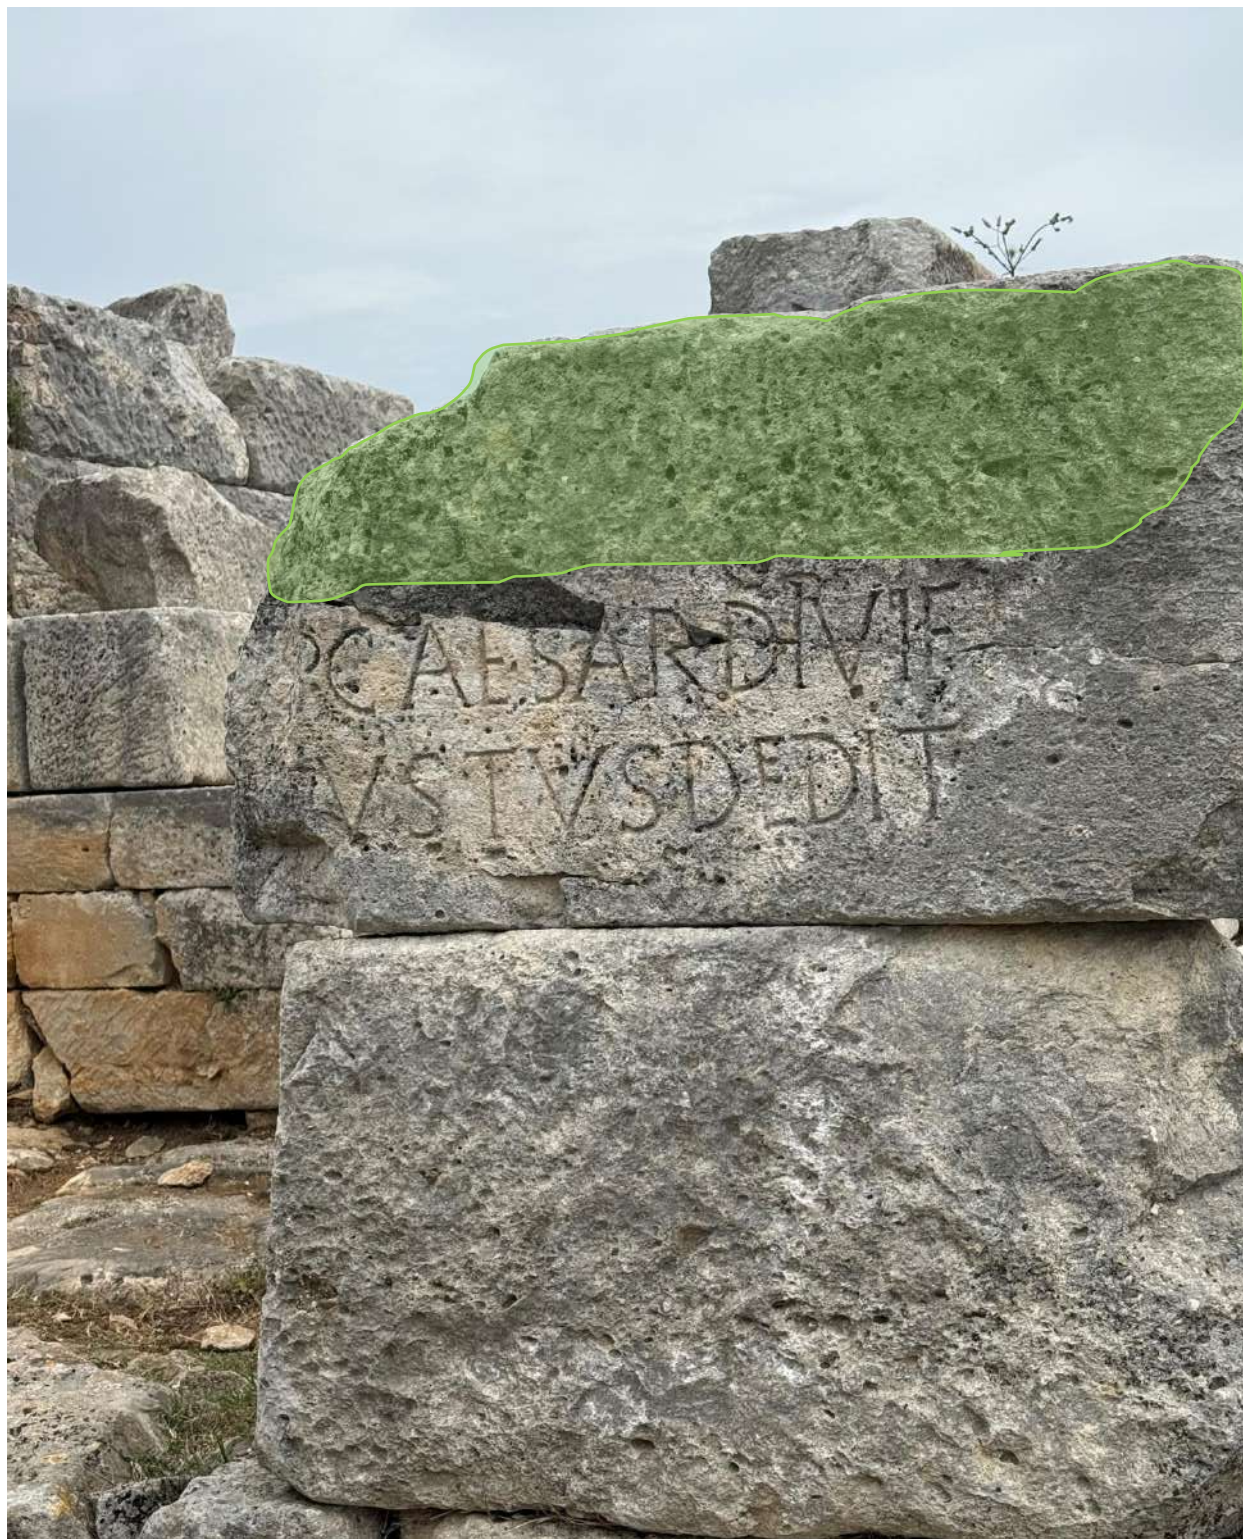
Figure 6 Inscribed stone block in Stoa B showing fractures, biological patina, and signs of erosion.

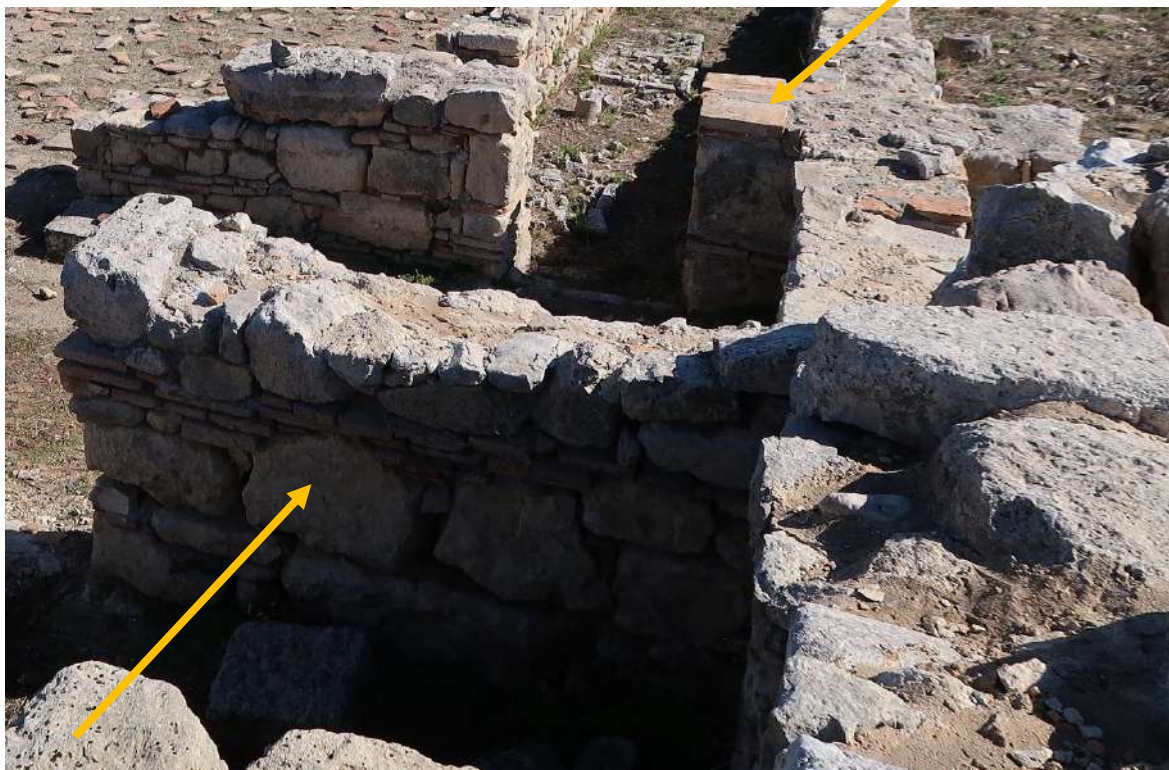
*Figure 7 Erosion of wall crests and deterioration of cementitious joint repointing and stabilization with improper infill (pottery fragments). Basilica E*

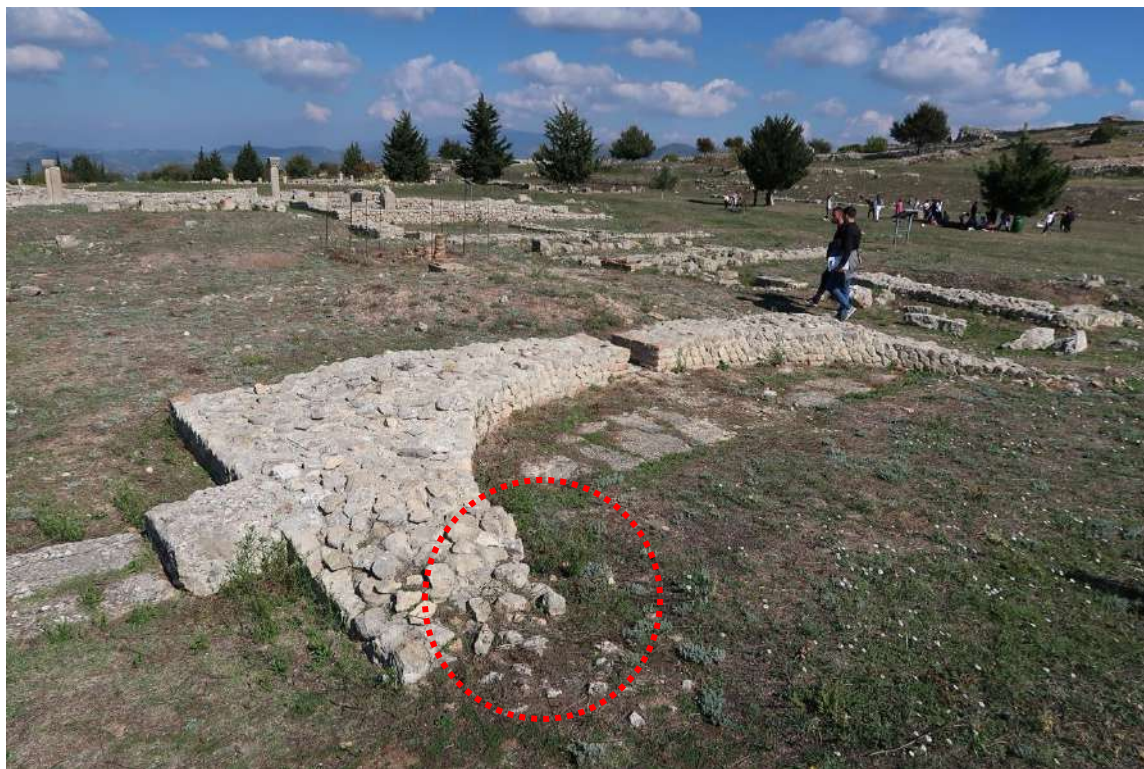
*Figure 8 Erosion of cementitious joint repointing, facilitating vegetation growth and loss of archaeological legibility.*

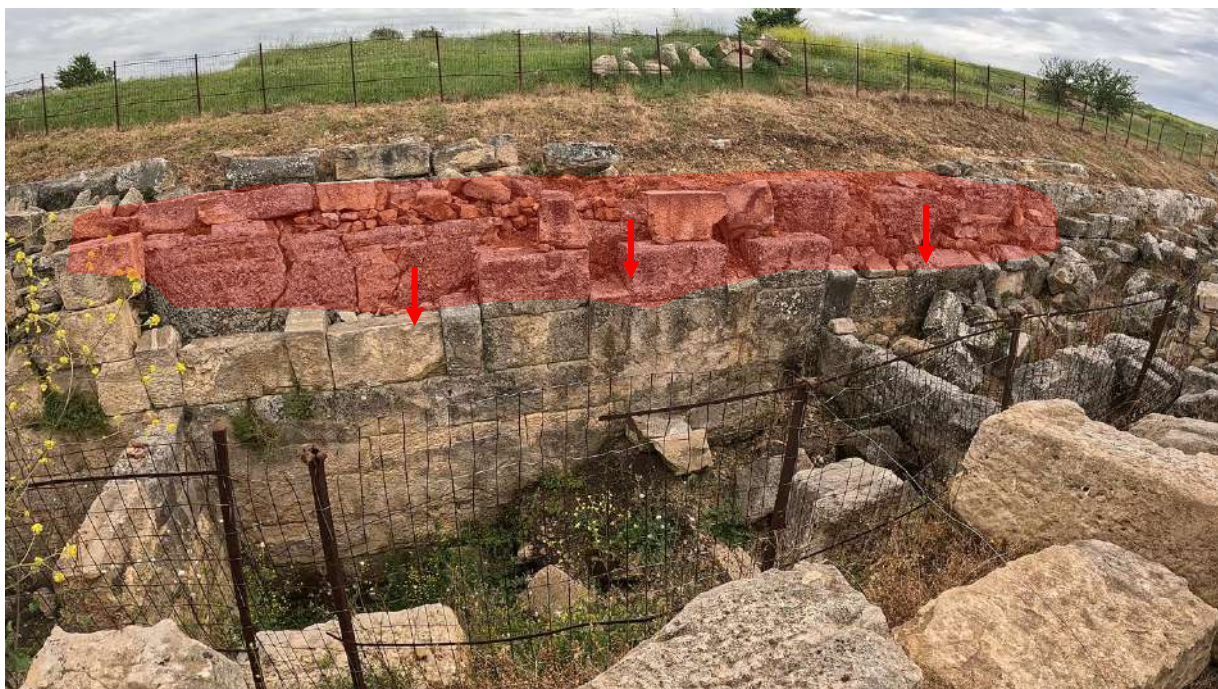
*Figure 10 Structural failures of the blocks in the retaining walls of the cistern, caused by soil pressure and slippage. Cisterna*

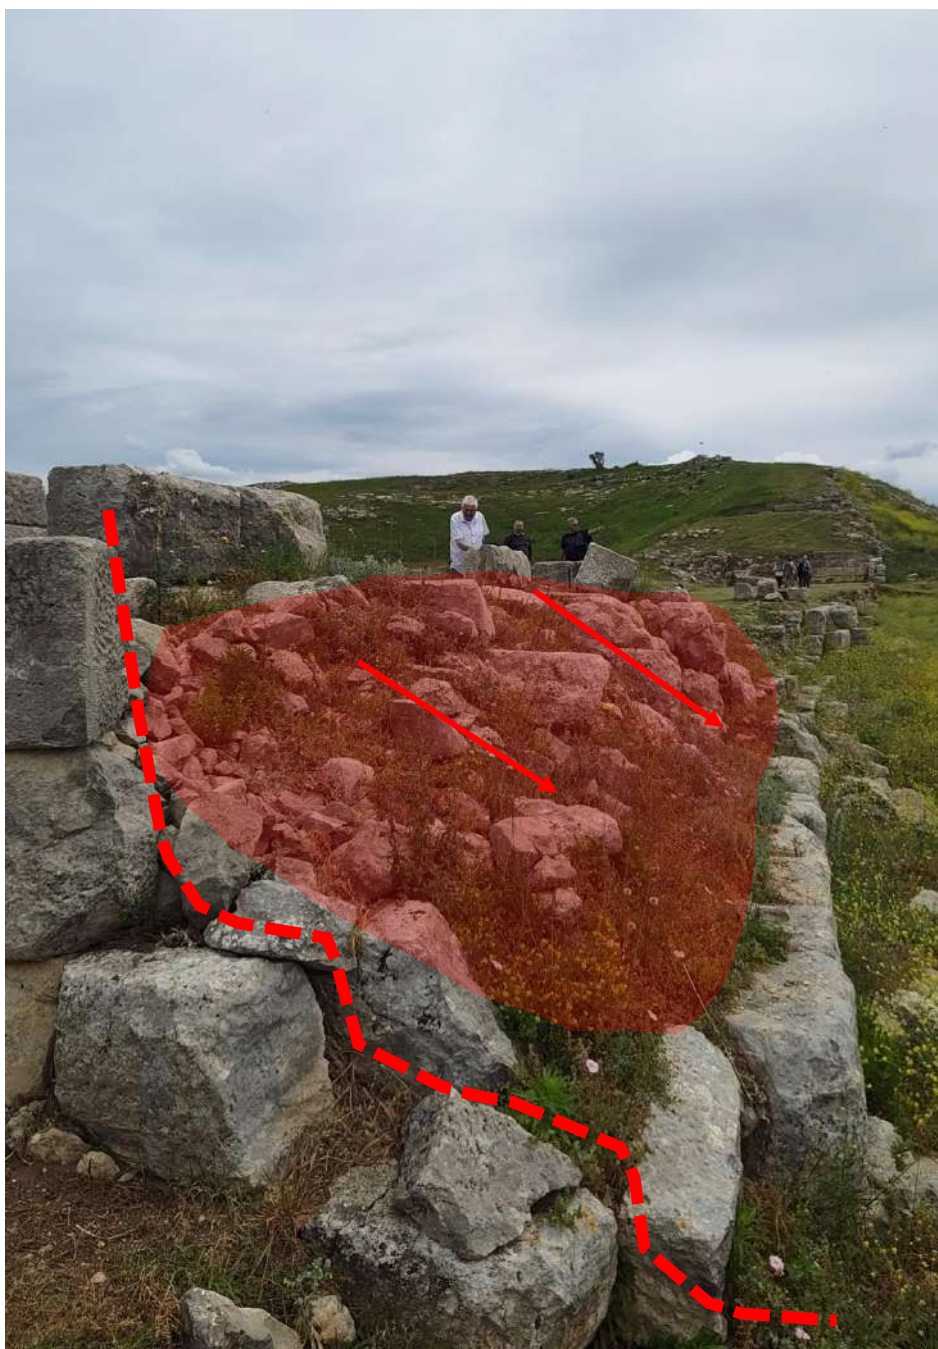
*Figure 61 Uncontrolled slippage of masonry blocks, potentially hazardous for both conservations and safety reasons.*

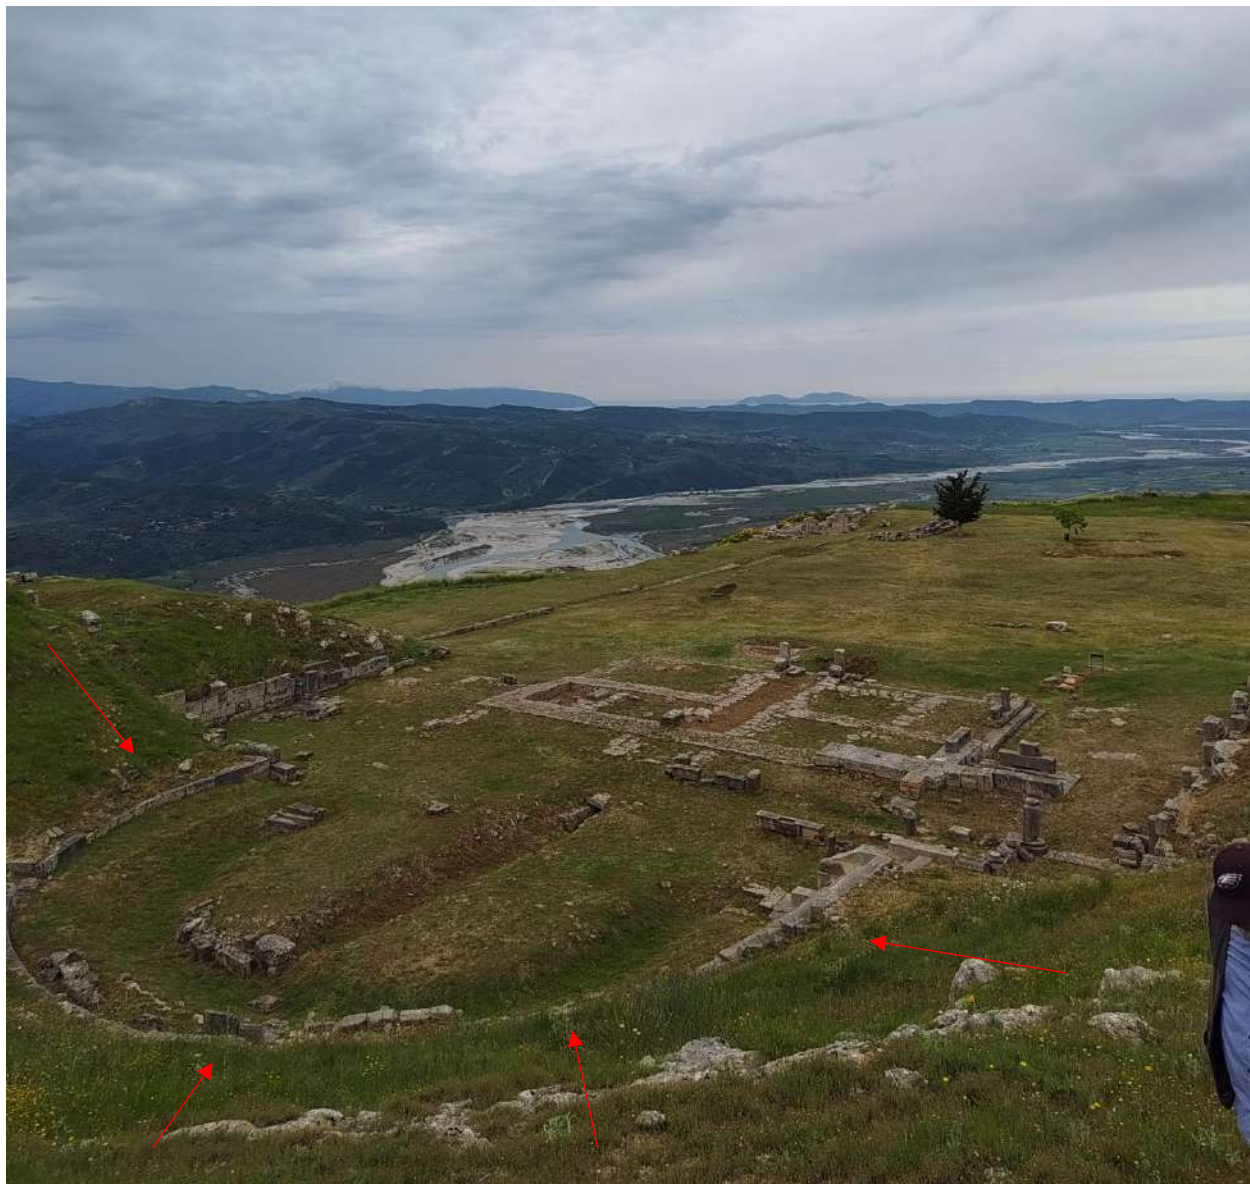
*Figure 12 Risk of landslides and slippages. Safety measures are required following hydrogeological analyses and archaeological sampling.*

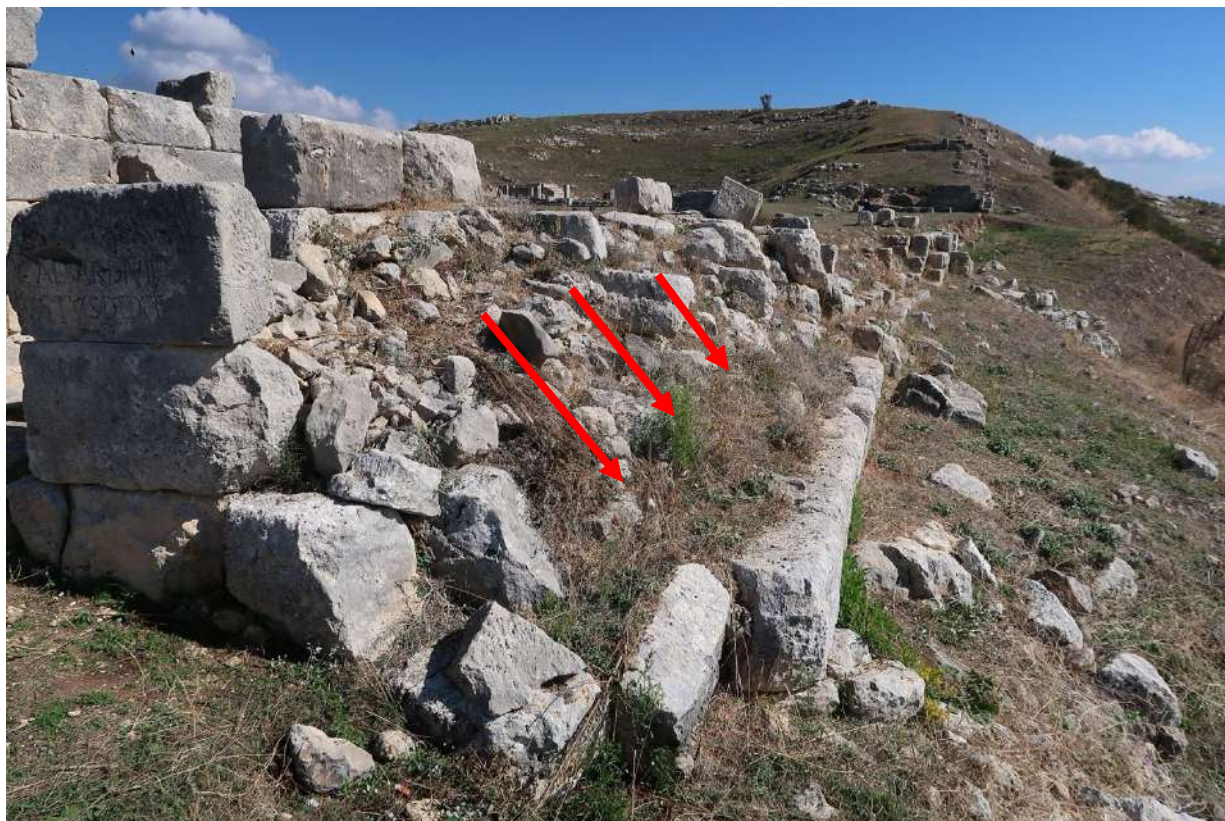
*Figure 13 Uncontrolled slippage of masonry blocks, potentially hazardous for both conservations and safety reasons.*

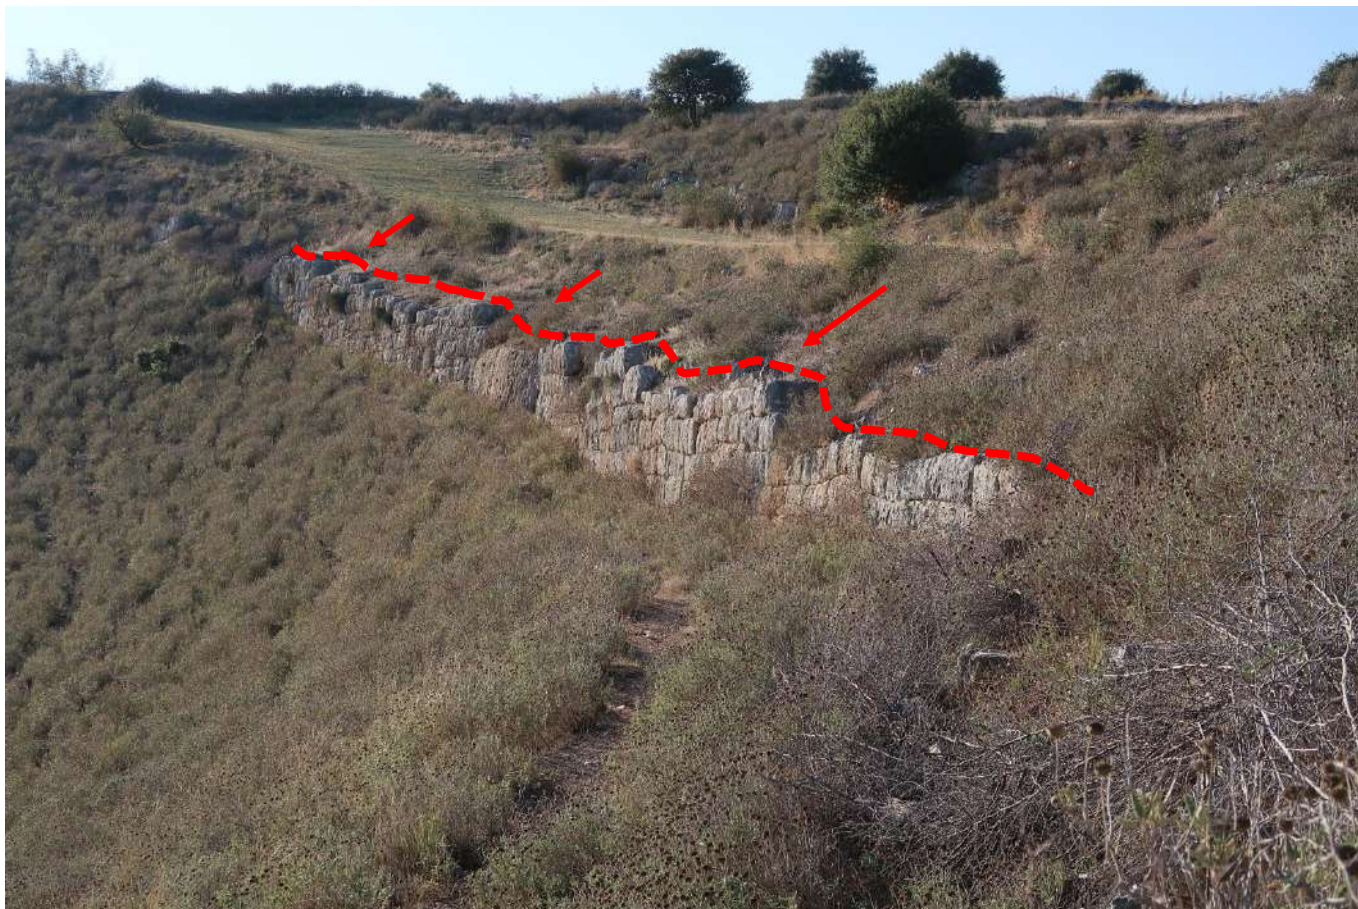
*Figure 14 Ancient walls of Klos largely illegible due to insufficient maintenance and site management; risk of soil pressure and slippage.*

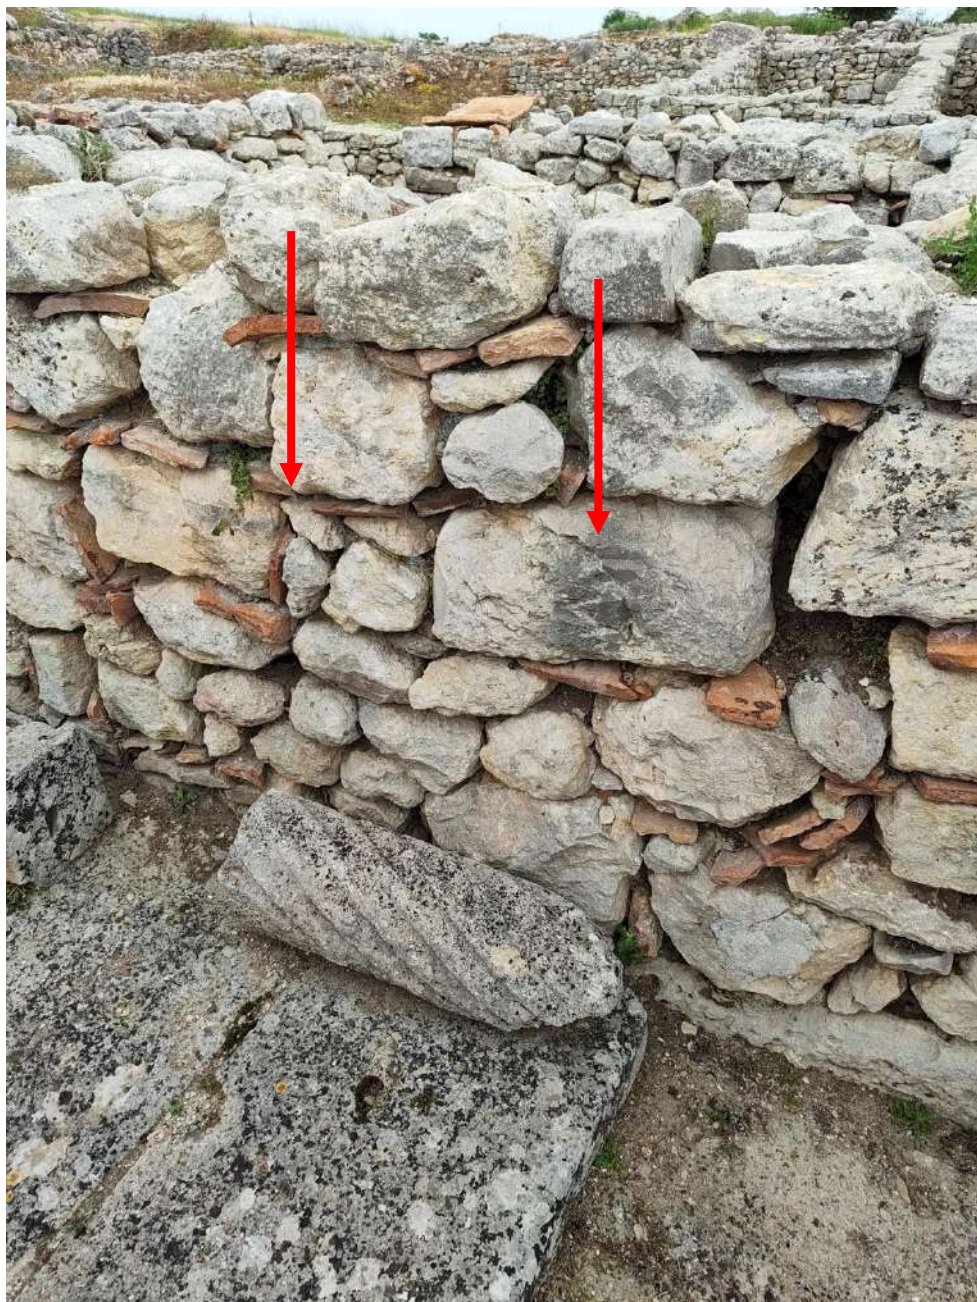
*Figure 15 Wall crest deformations and structural failures; ineffective stabilization with improper infill (pottery fragments).*

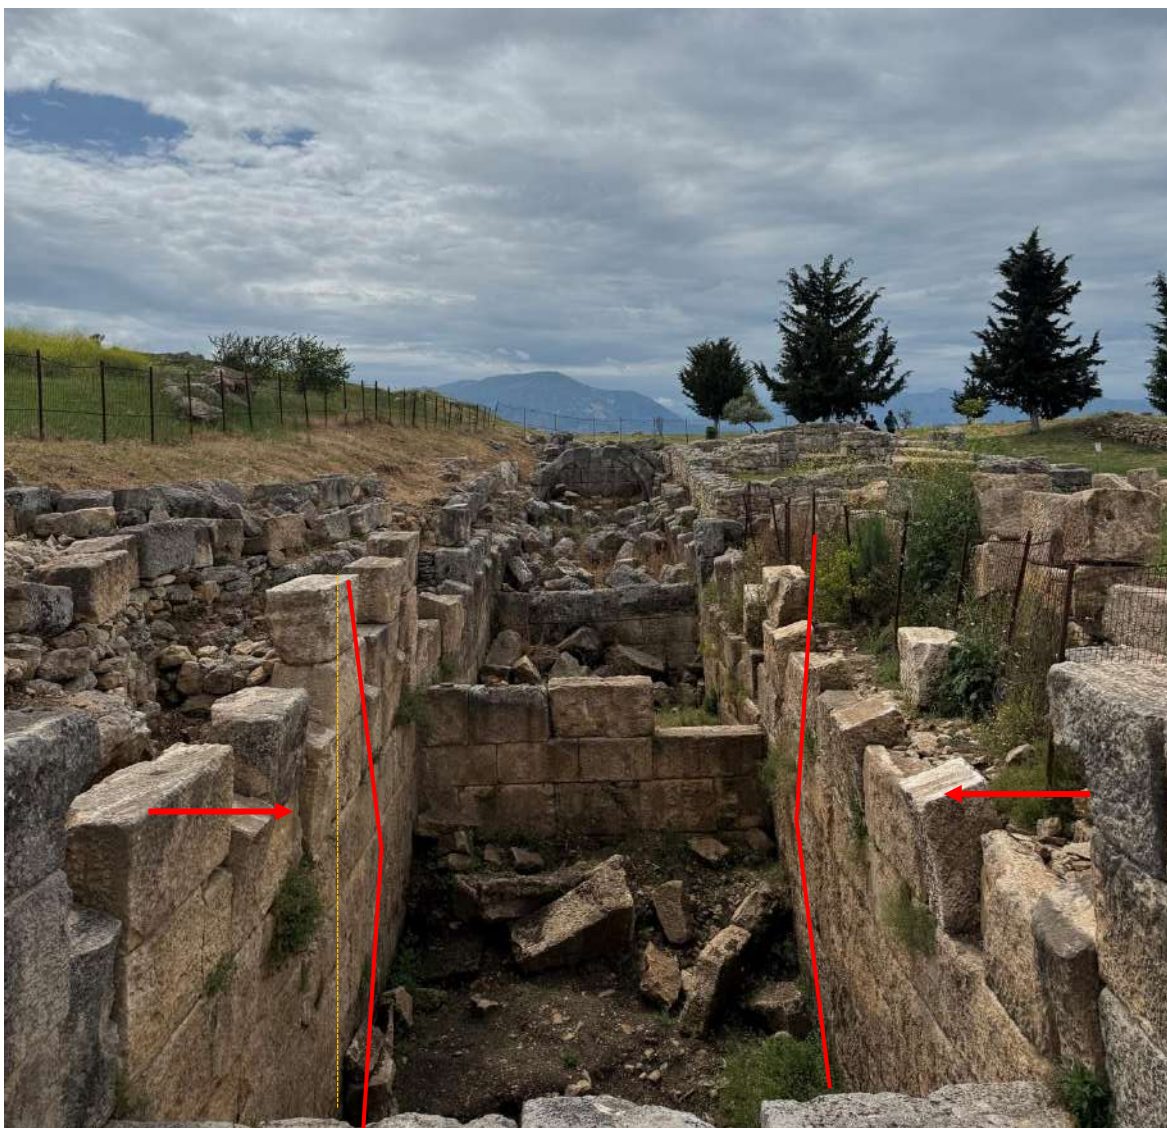
*Figure 16 Structural failures of the blocks in the hypogean retaining walls of the cistern, caused by soil pressure and slippage.*

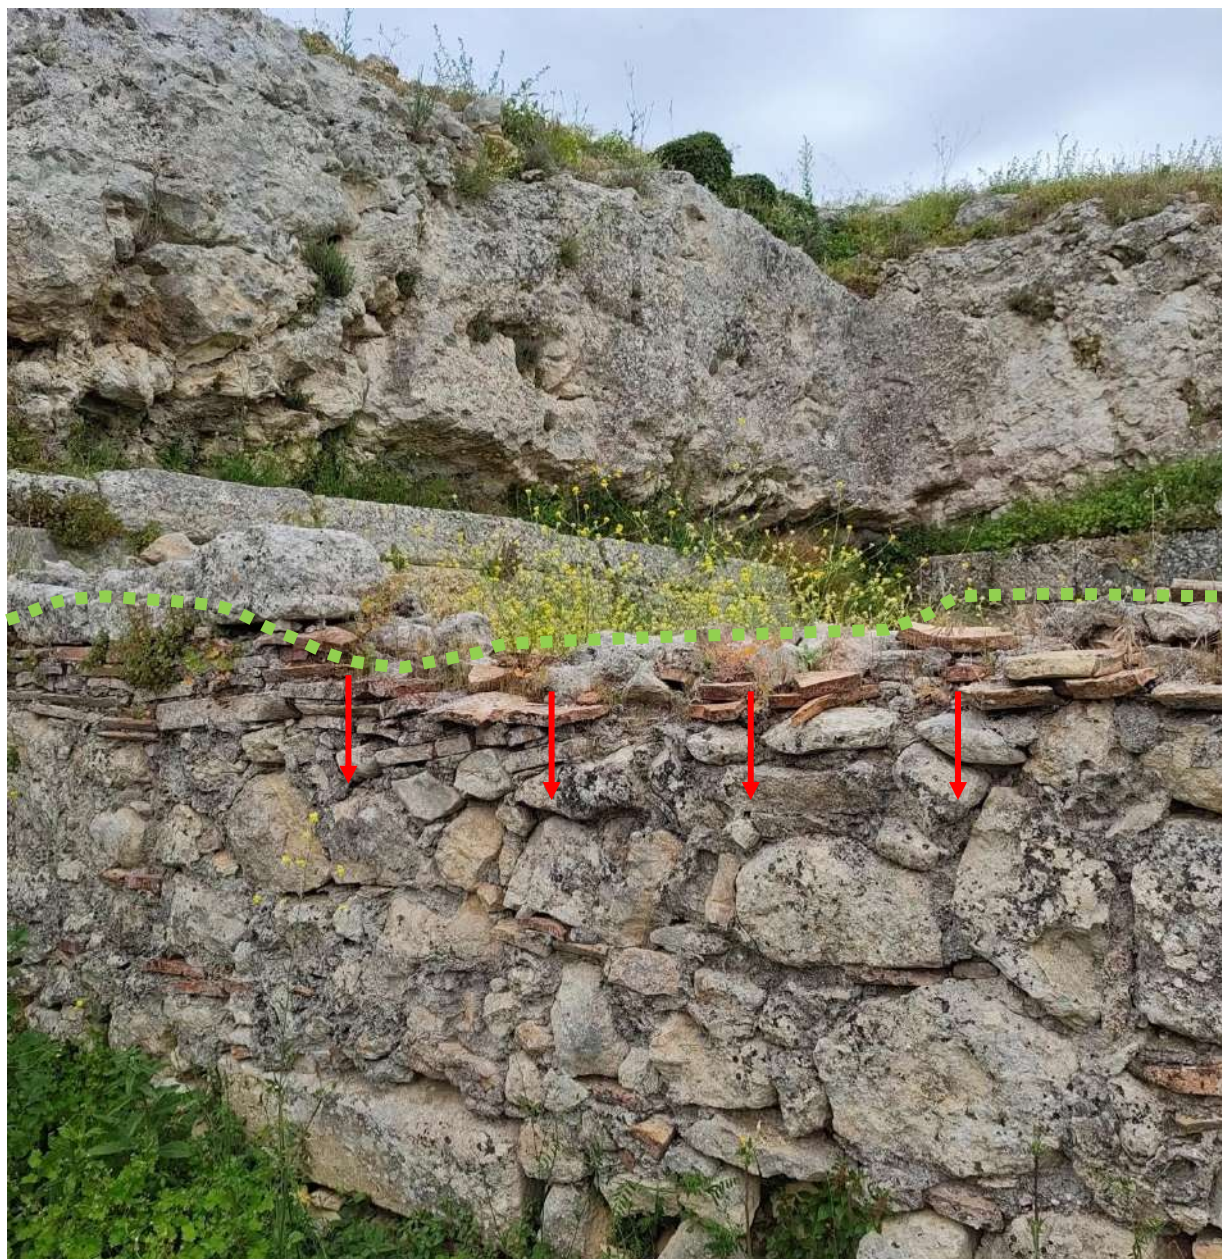
*Figure 17 Wall crest deformations and structural failures; ineffective stabilization with improper infill (pottery fragments) and scattered, poorly executed repointing with cementitious mortar.*

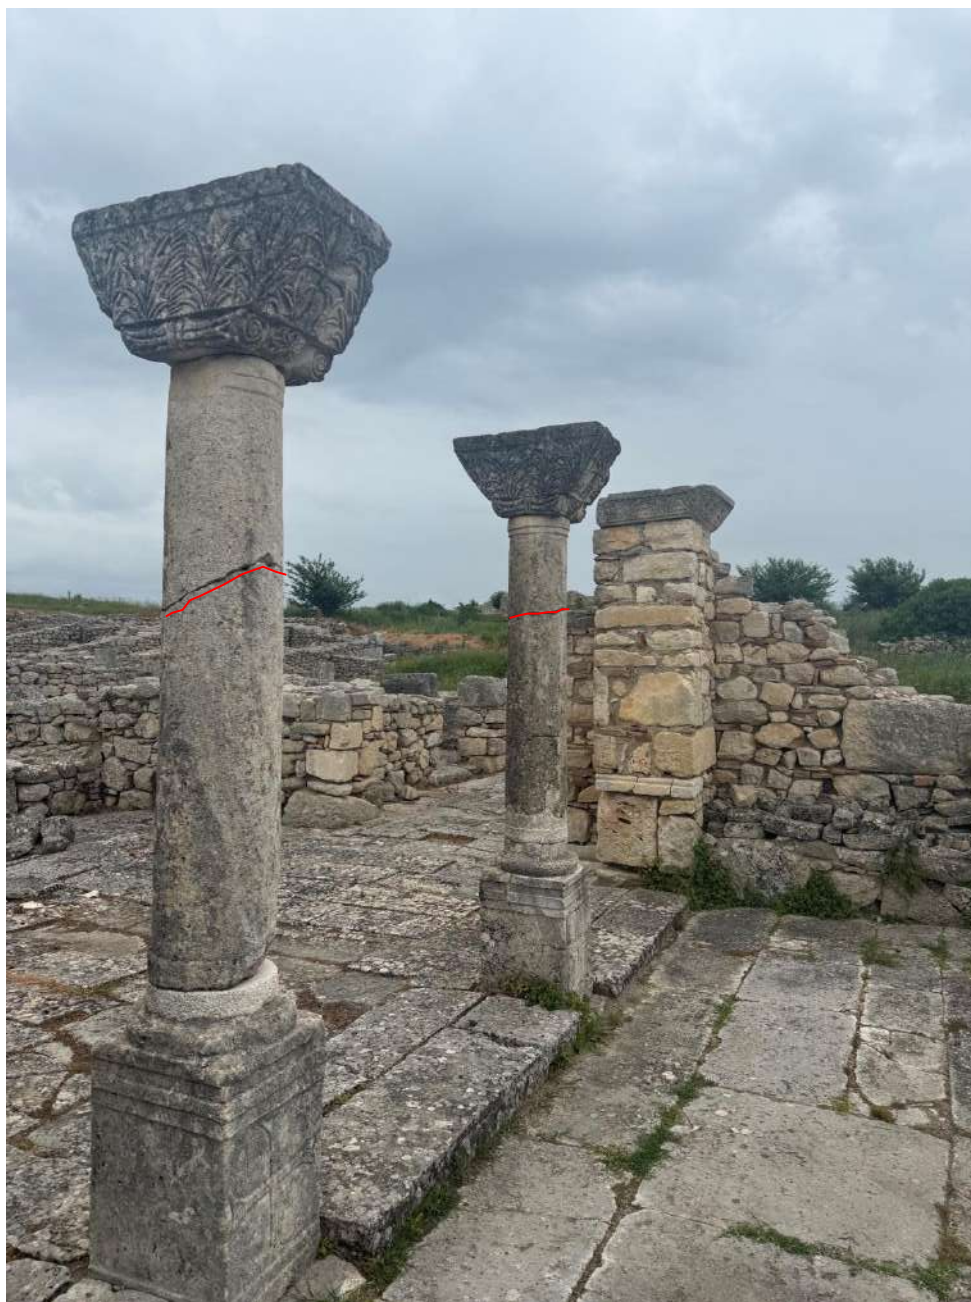
*Figure 19 Deep fractures visible in the columns of Basilica B.*

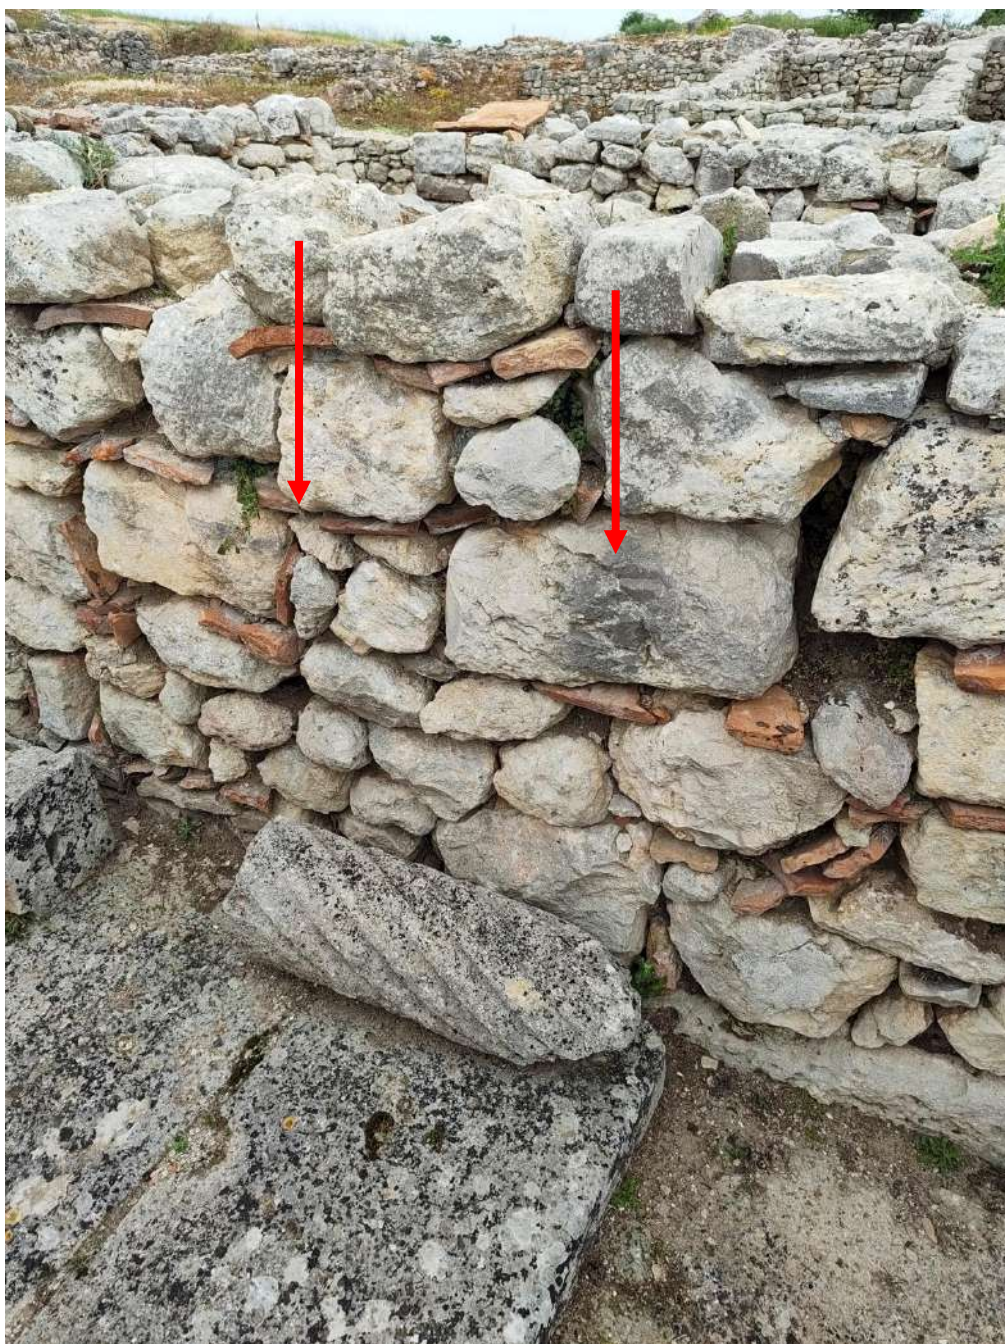
*Figure 20 Wall crest deformations and structural failures; ineffective stabilization with improper infill (pottery fragments).*

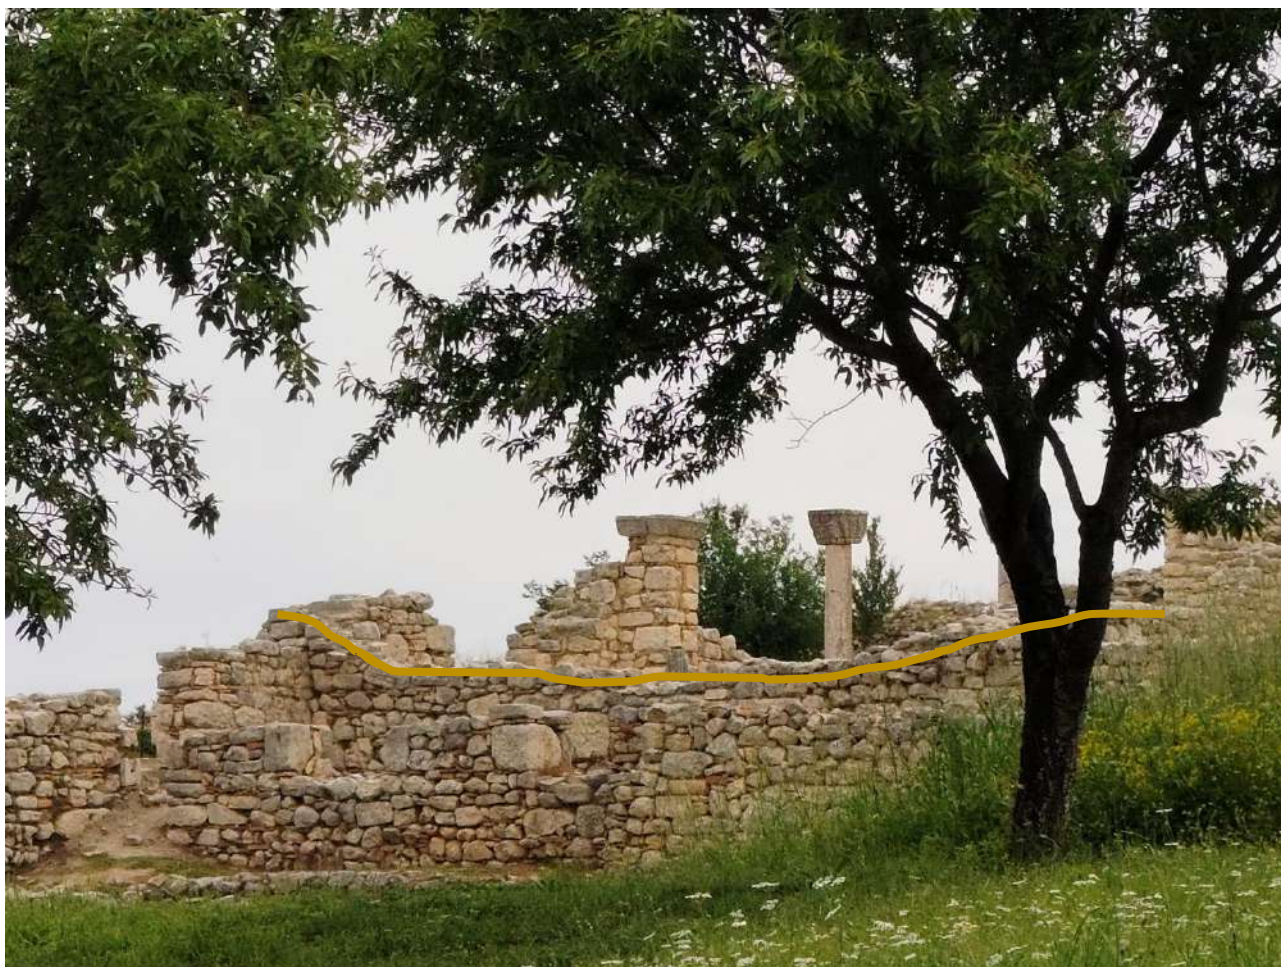
*Figure 81 Absence of a protective casings to stabilize the wall crests and prevent settlement, material loss, and vegetation growth.*

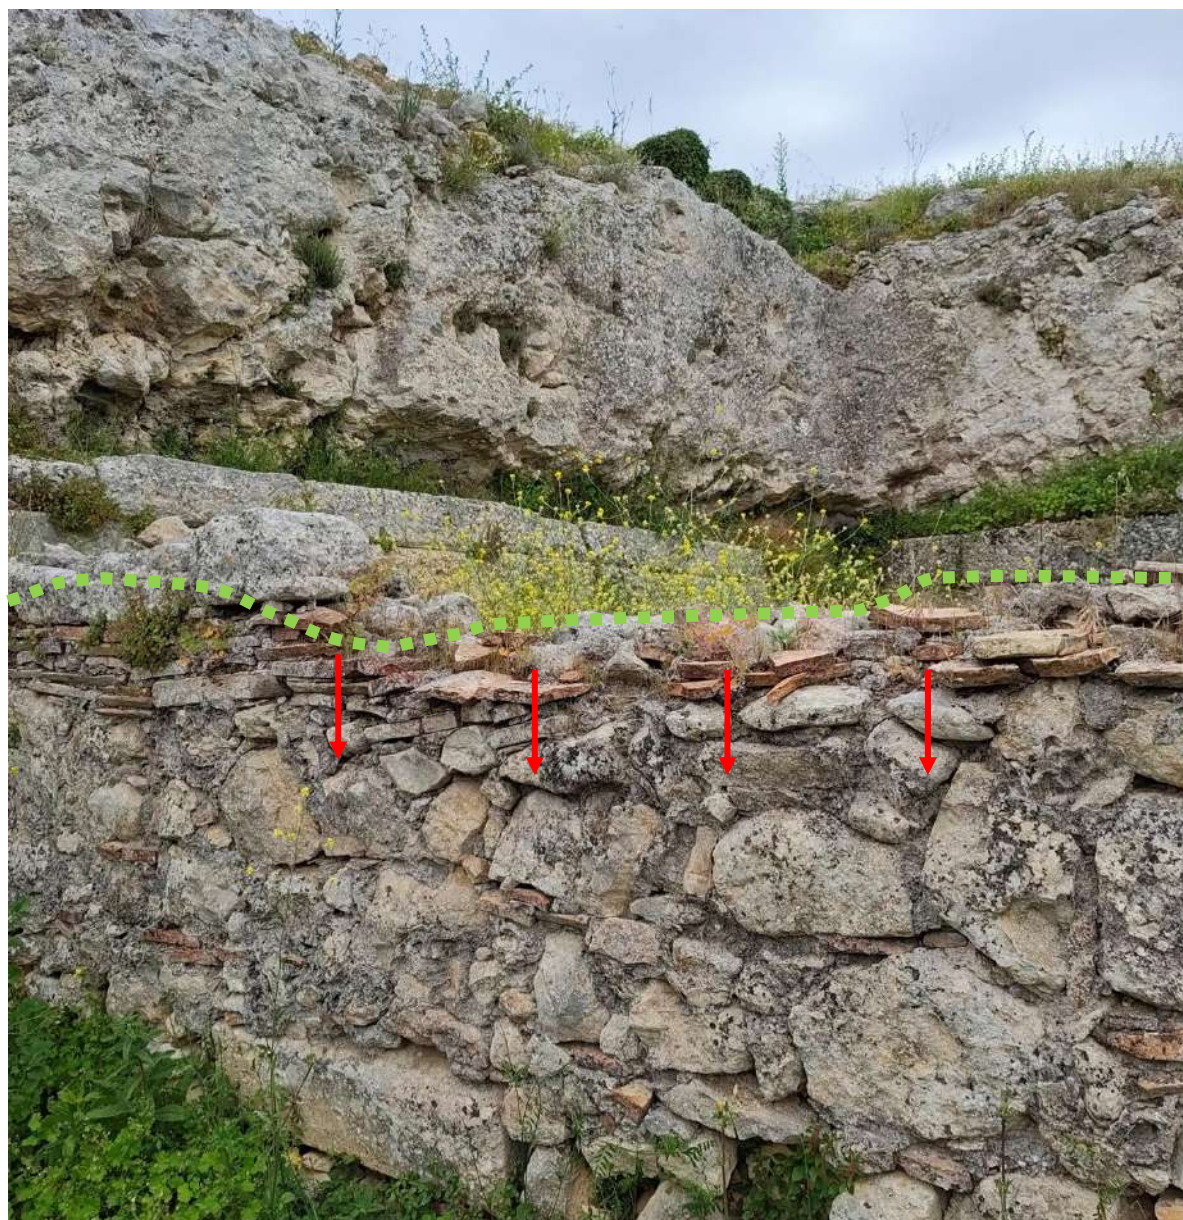
*Figure 93 Wall crest deformations and structural failures; ineffective stabilization with improper infill (pottery fragments) and scattered, poorly executed repointing with cementitious mortar.*
