Financuar nga  
Bashkimi Evropian

ITALIAN AGENCY  
FOR DEVELOPMENT  
COOPERATION

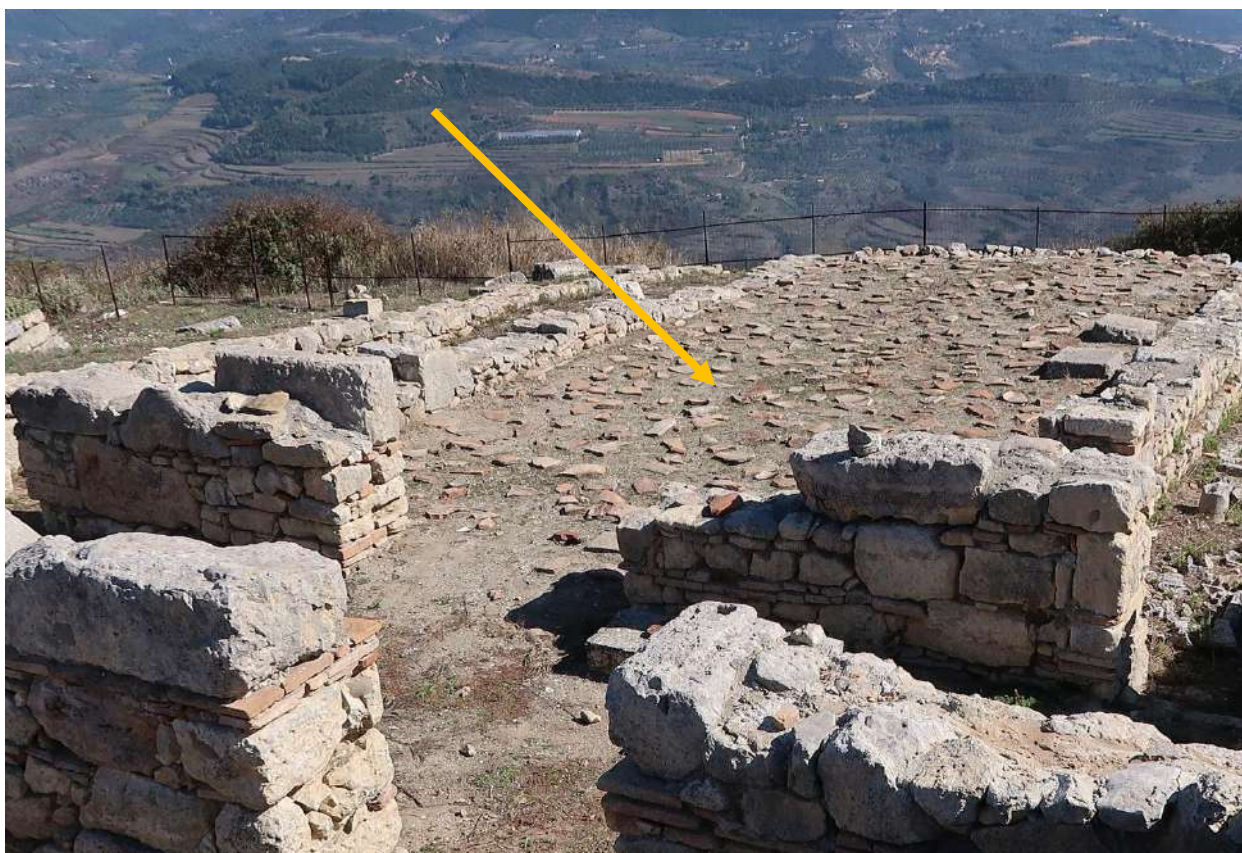
*Figura 104 Resettlement and compaction of the soil with improper infill (pottery fragments), facilitating weeds growth.*

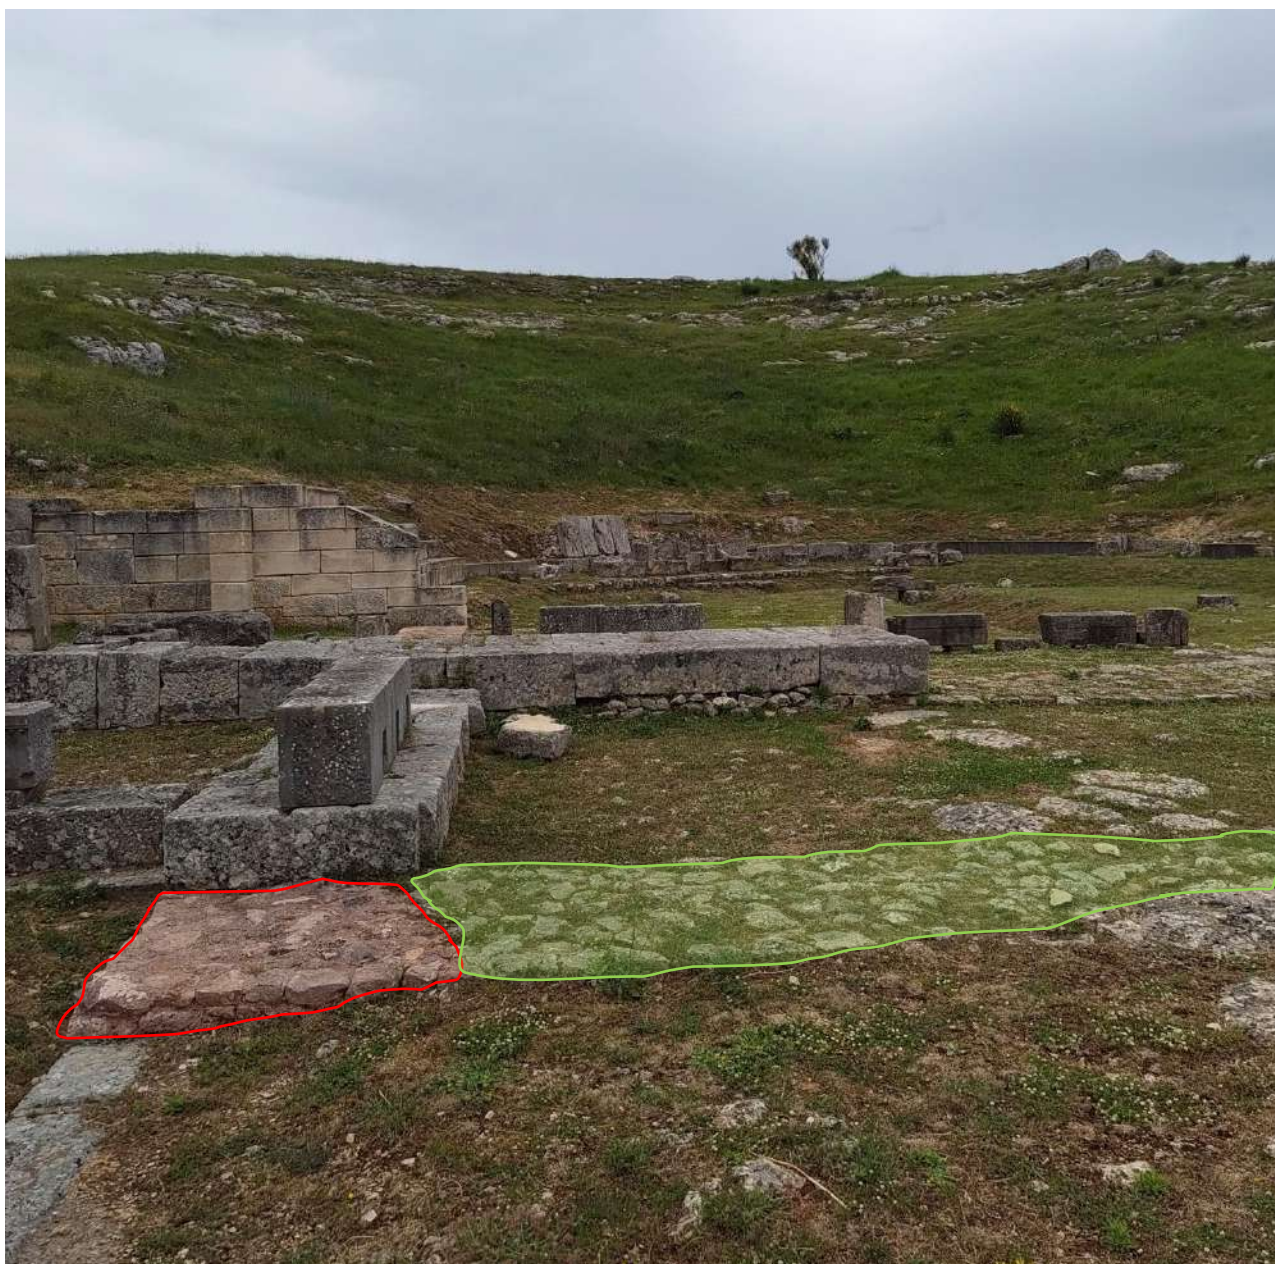
*Figure 25 Incomplete cementitious joint repointing, facilitating vegetation growth and loss of archaeological legibility.*

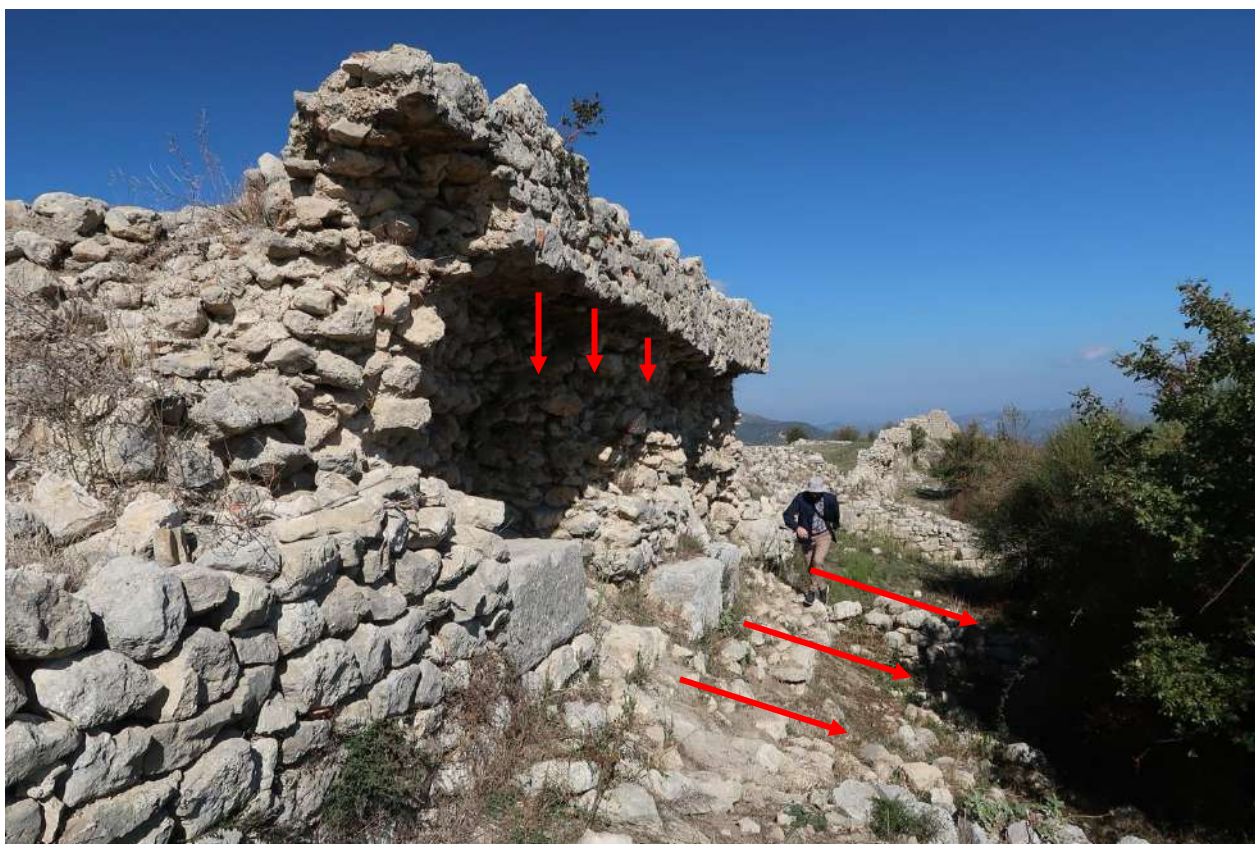
*Figure 27 Significant loss of masonry blocks, posing hazards to both conservation and safety, possibly due to anthropogenic activity, and facilitating vegetation rooting further endangering the walls' stability.*

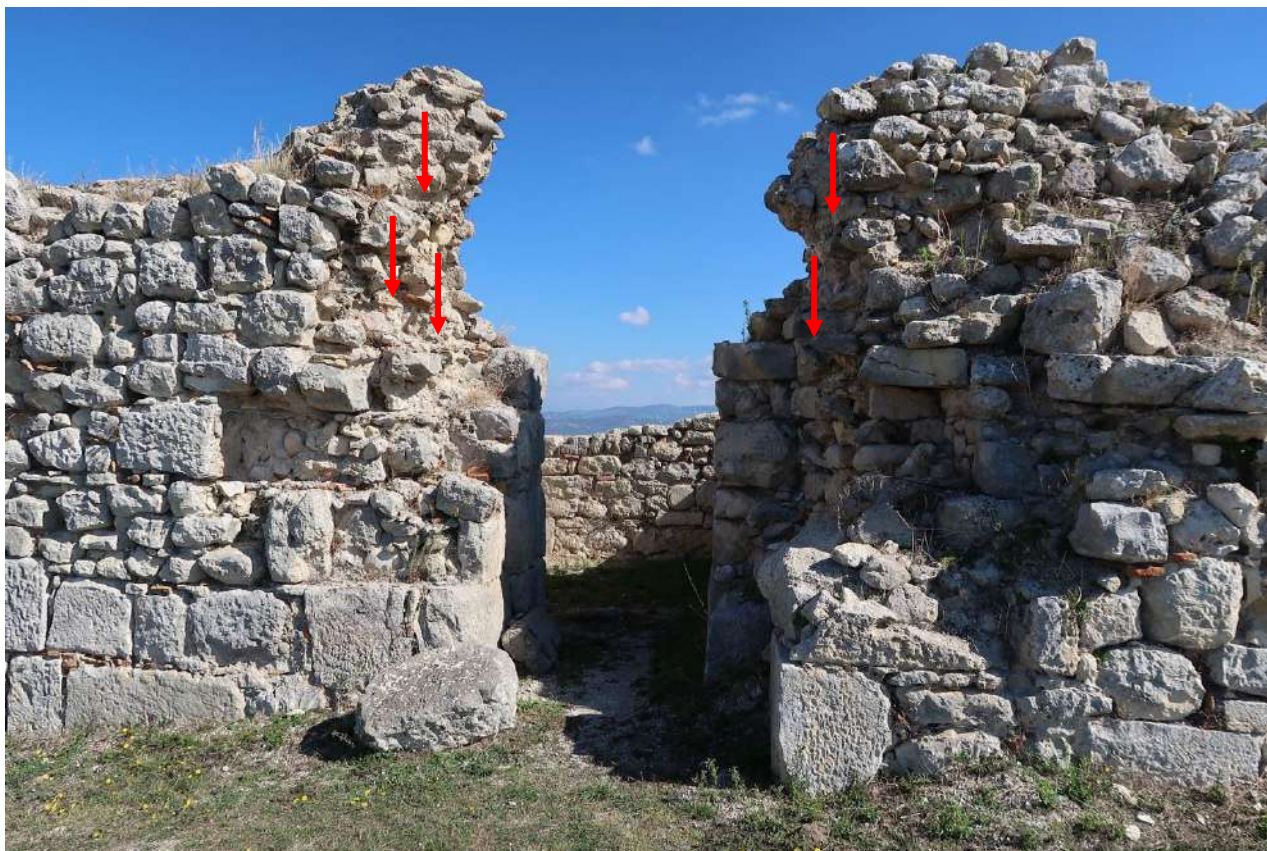
*Figure 29 Risk of wall-crest collapse and structural failure of the portal as shown by the concrete lintel replacements already arranged along the openings of the walls and towers, posing a hazard to visitor circulation.*

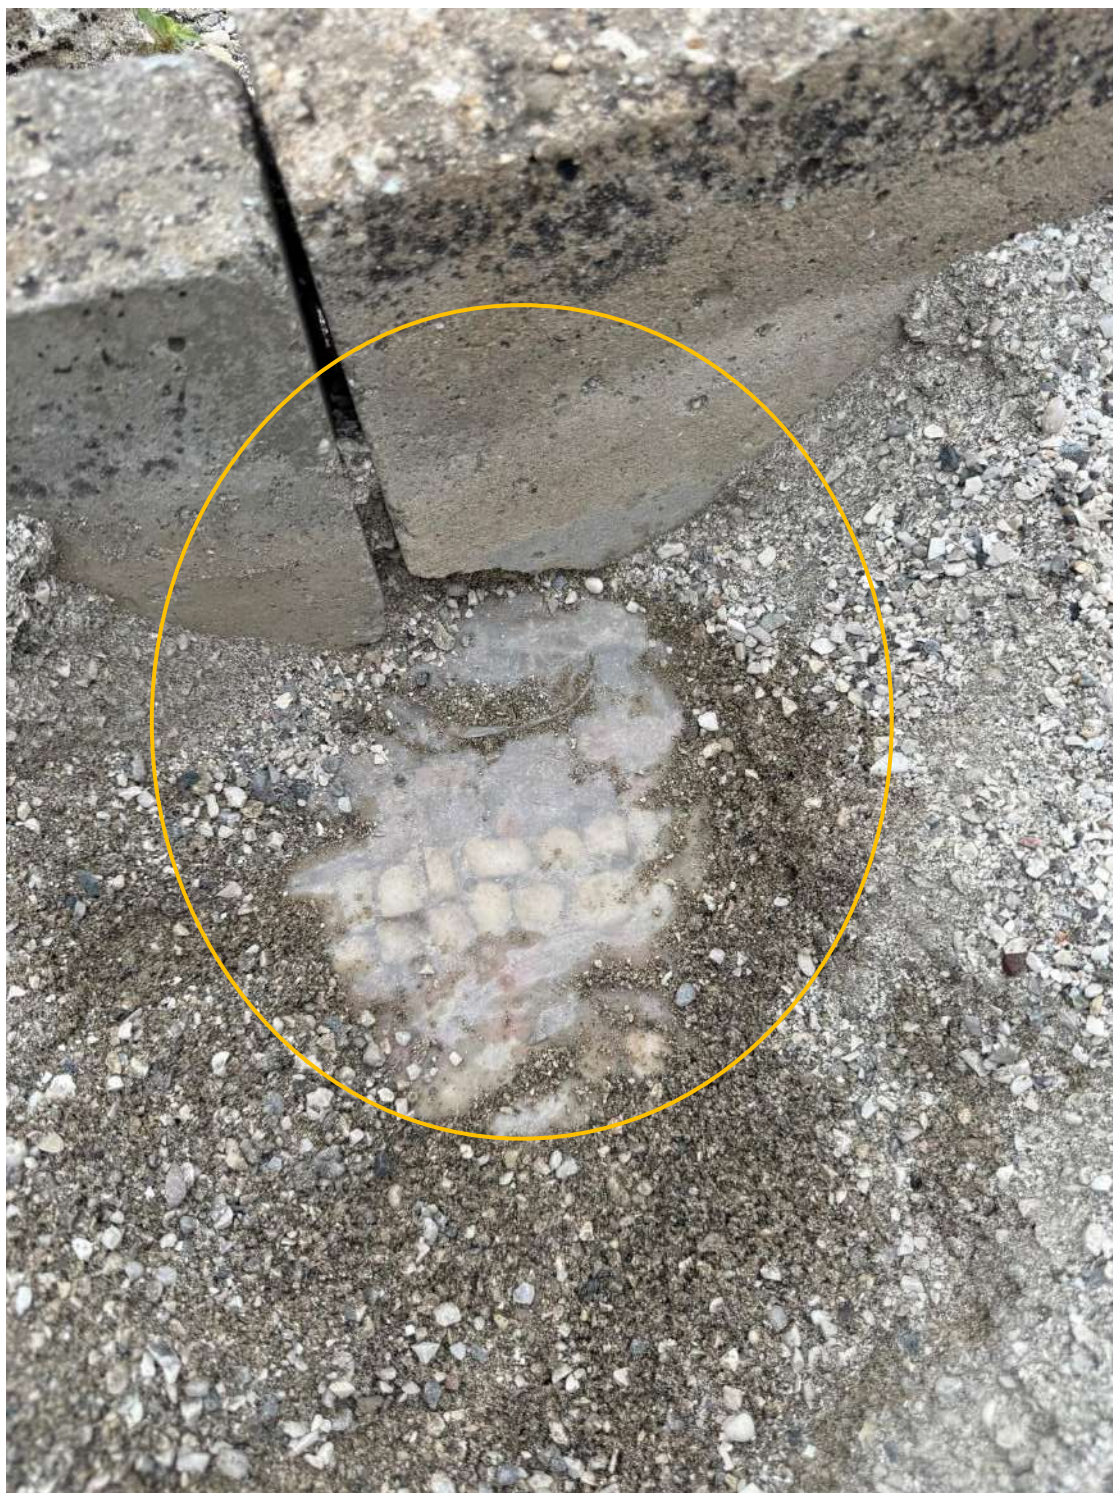
*Figure 30 Removal of the plastic sheet covering the mosaic of Basilica B to allow inspection of its condition and replacement with a more suitable protective material, such as geotextile.*

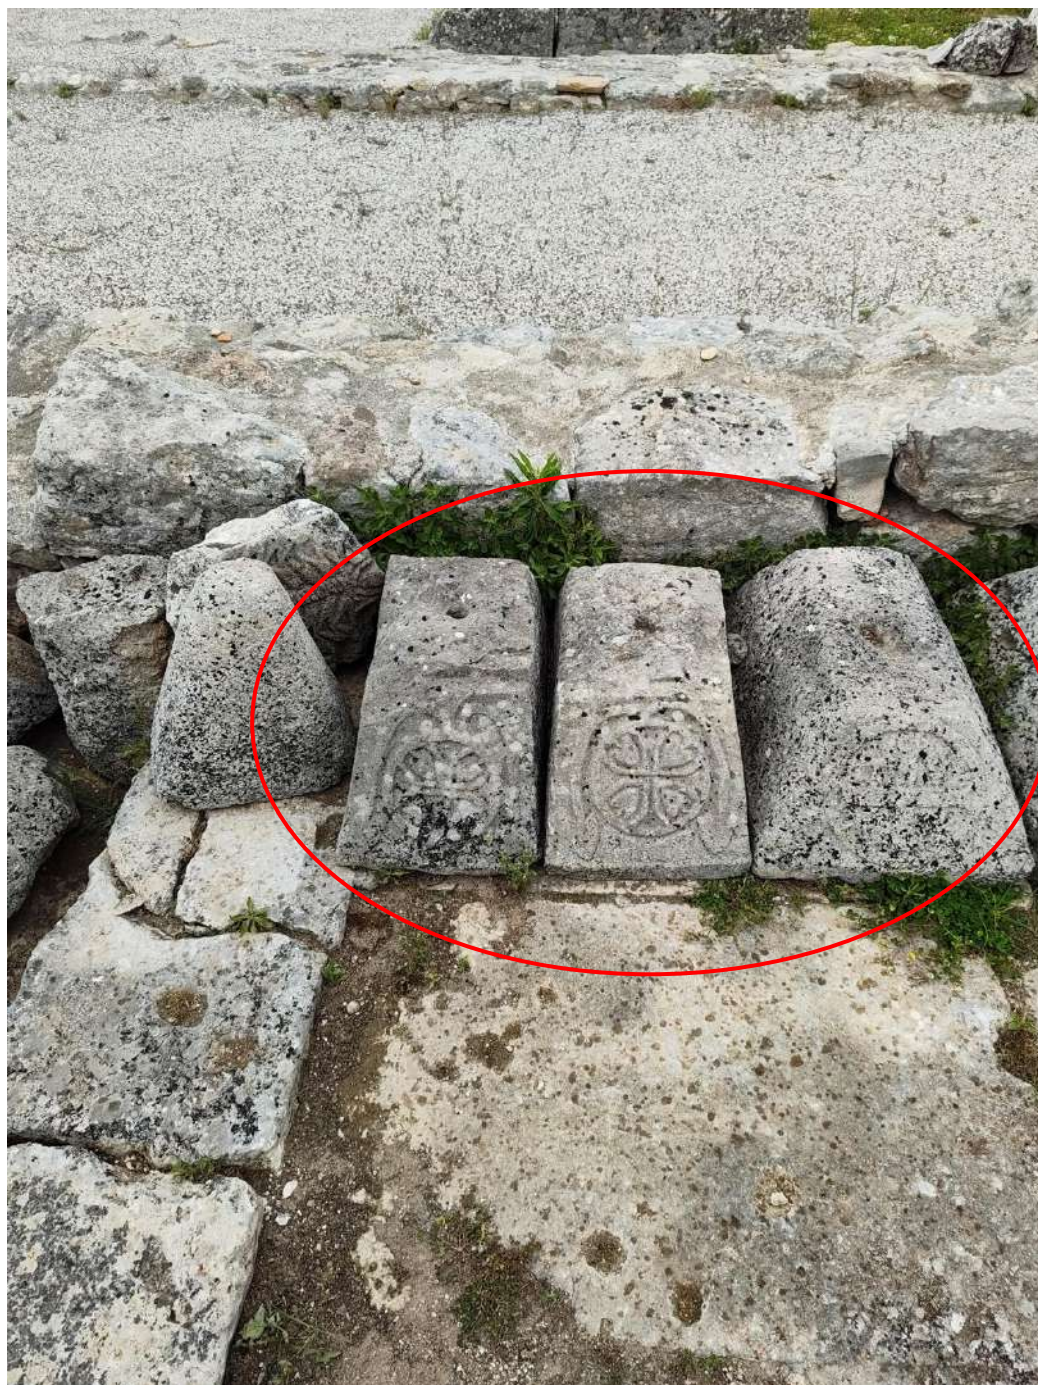
*Figure 31 Erratic elements with inscriptions, requiring cataloguing and relocation to a safe environment suitable for conservation.*

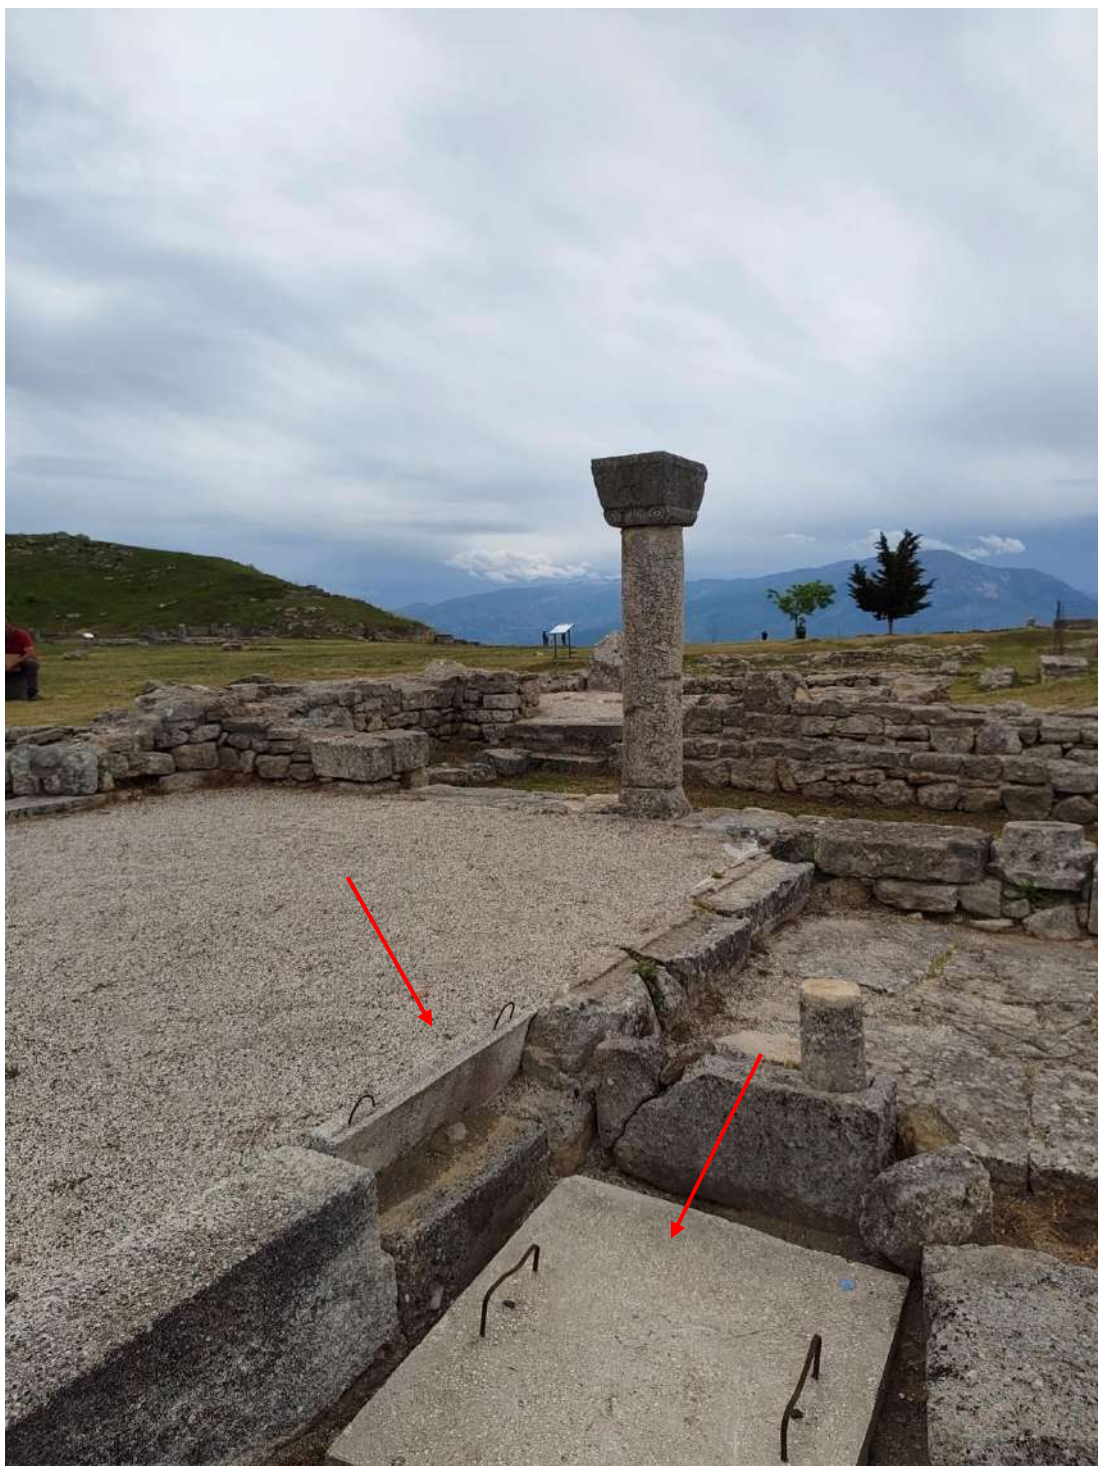
*Figure 33 Concrete blocks used as infill for missing areas and for protection, temporary in appearance and inconsistent with both their intended function and the site's aesthetics.*

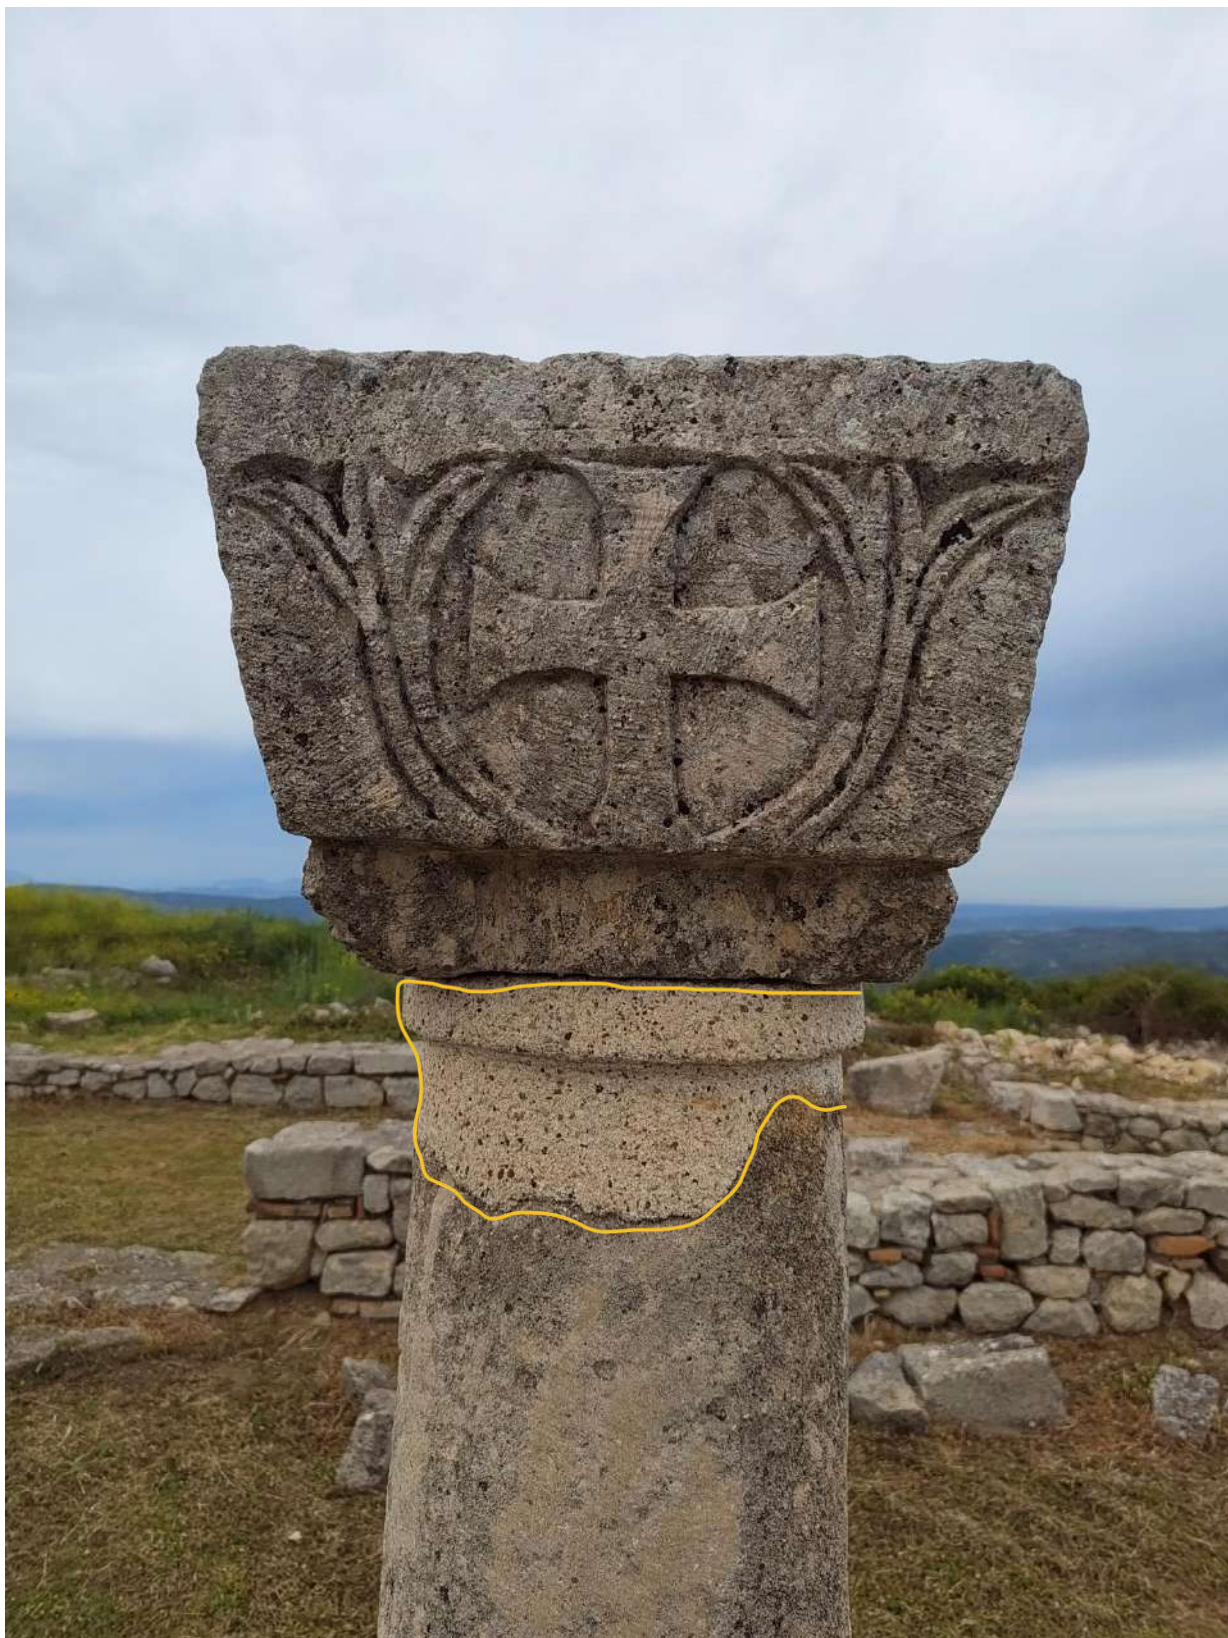
*Figure 34 Reconstruction of a portion of the column using incongruous material.*

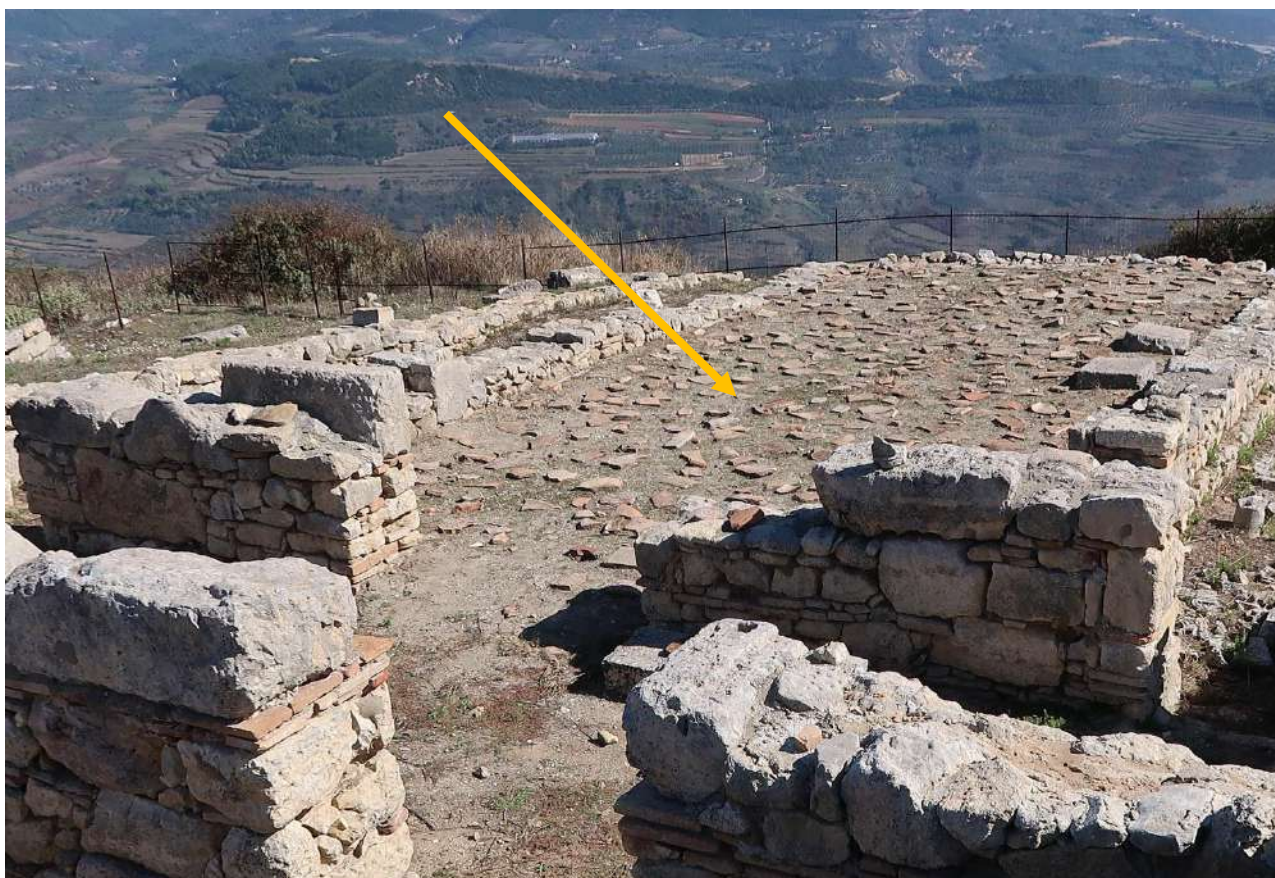
*Figure 35 Resettlement and compaction of the soil with improper infill (pottery fragments), facilitating weeds growth.*

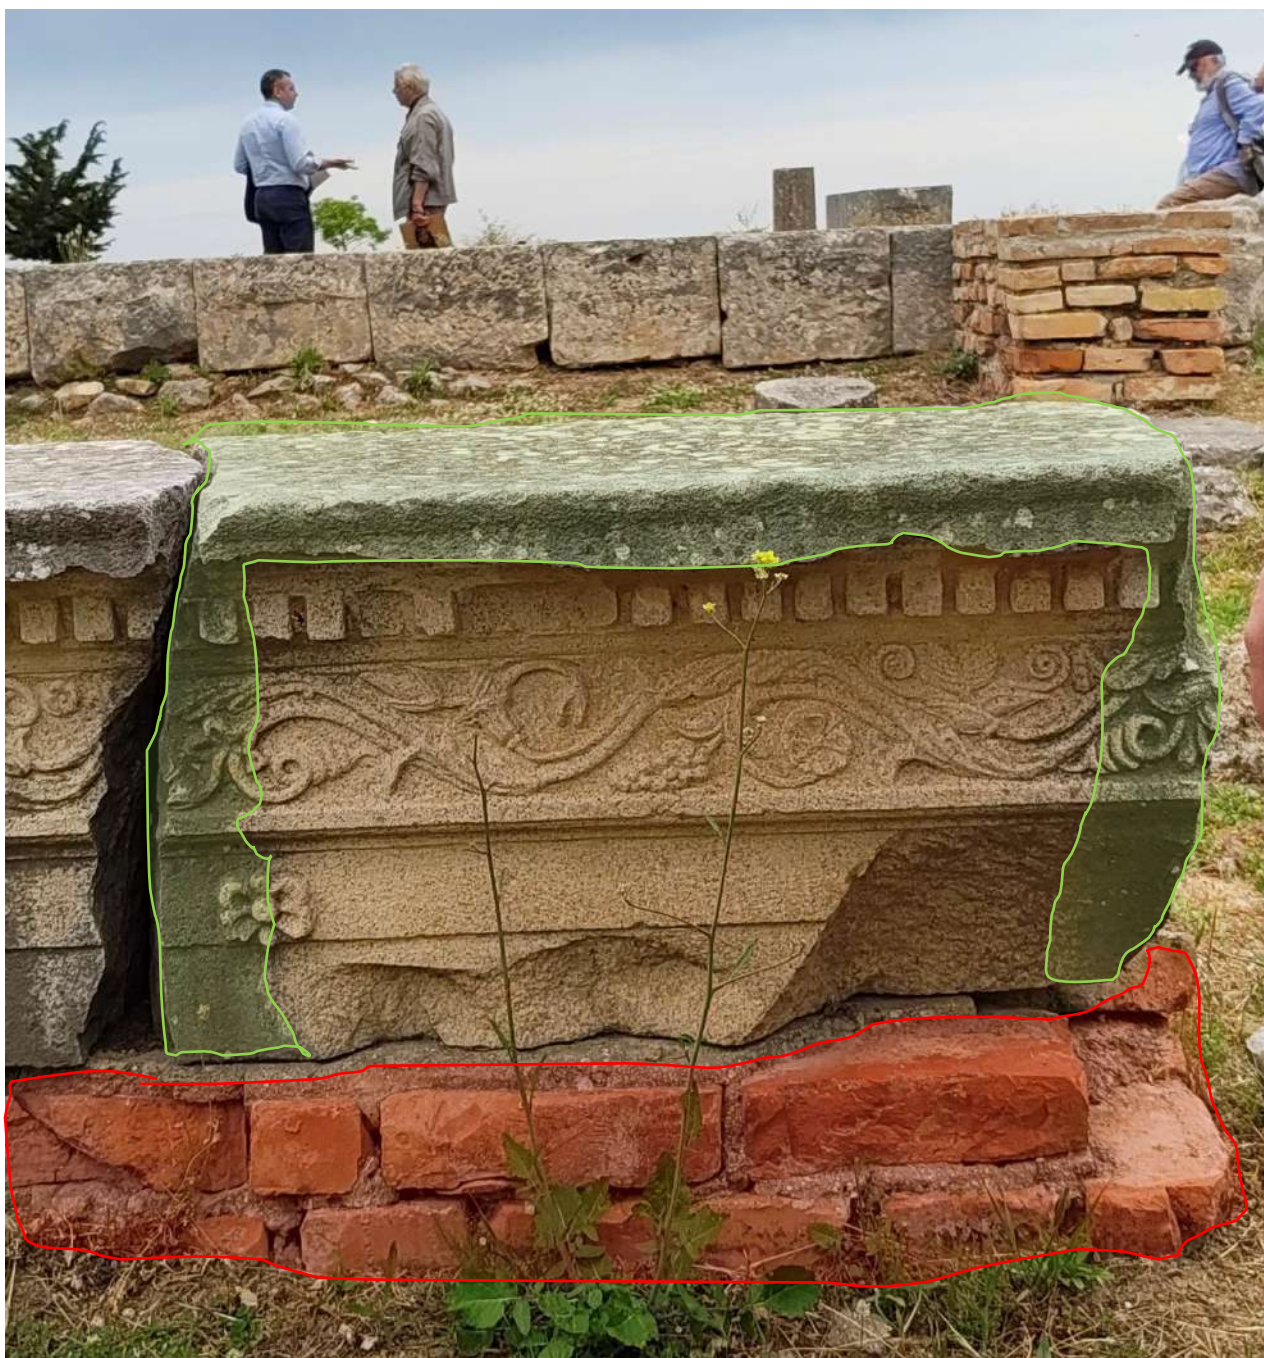
*Figure 36 Decorated erratic elements scattered around Bylis theatre, poorly arranged and affected by biological patina and erosion; requires cataloguing and relocation for proper conservation.*
